MEMORANDUM

RE: AltEn, LLC

Subject: Site Visit Report (Stormwater Aspects Only) from Inspection – Mark Pomajzl, Hillary Stoll, and Jason Holsten Present

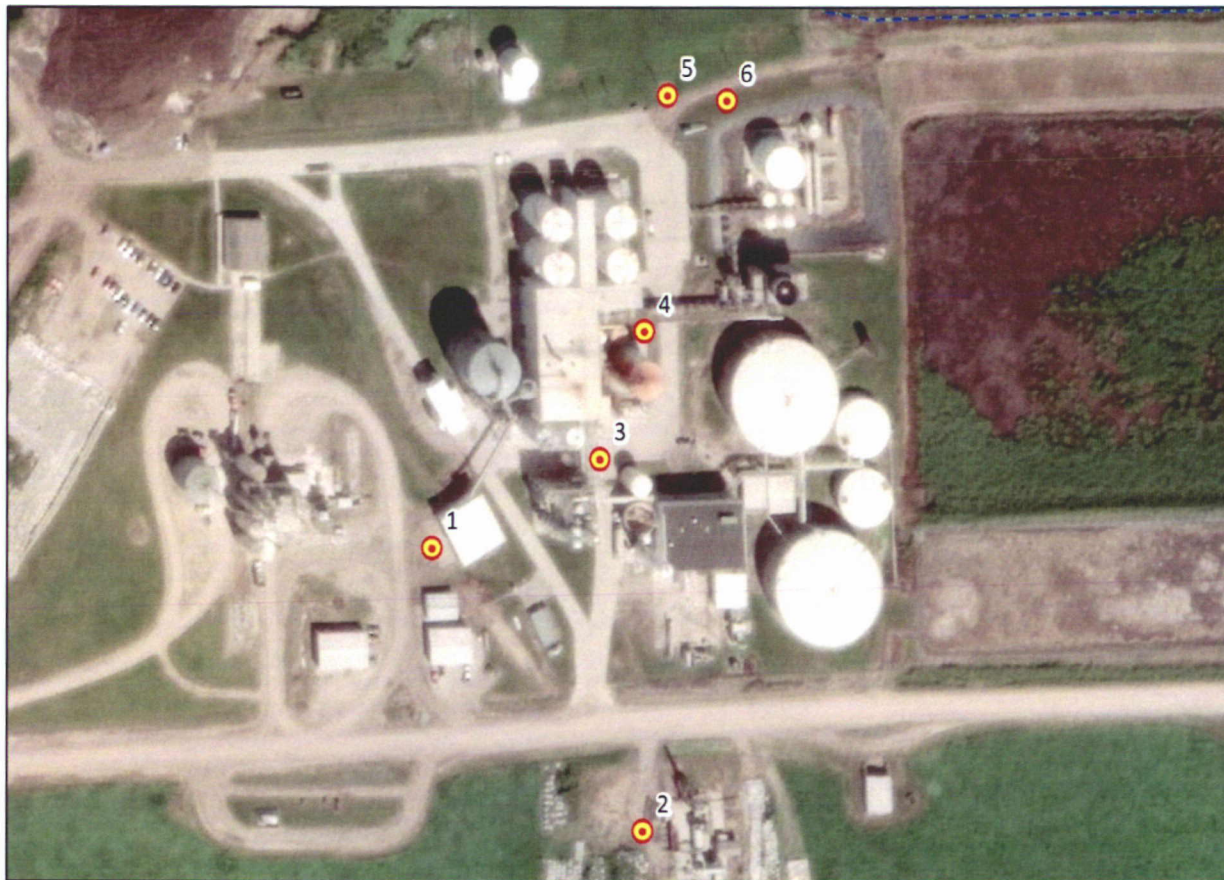
AltEn LLC Site Visit - Map 1
September 11, 2020

OA1 is the distiller's grains staging area. Solids are conveyed to a collection area where they are loaded onto trucks and transported to various areas for storage. The pad used to load wet distiller's grains contains residue that is being washed into an area that drains to a ditch leading to storm water outfall 001 (photos 1, 2).

OA6 is the tank farm depicted in photo 17. Inside the tank farm berm are two totes of unlabeled and unknown material along with some trash. On the north side of the berm is spilled red granular material, which is depicted in photo 18. This material is similar to the material observed in the totes.
