**MEMORANDUM**

From: AltEn, LLC, Mead Nebraska

Date: July 31, 2019 (12:00 pm – 4:36 pm)

RE: Inspection – Mark Pomajzl, Jason Windhorst, Jason Holsten, Hillary Stoll

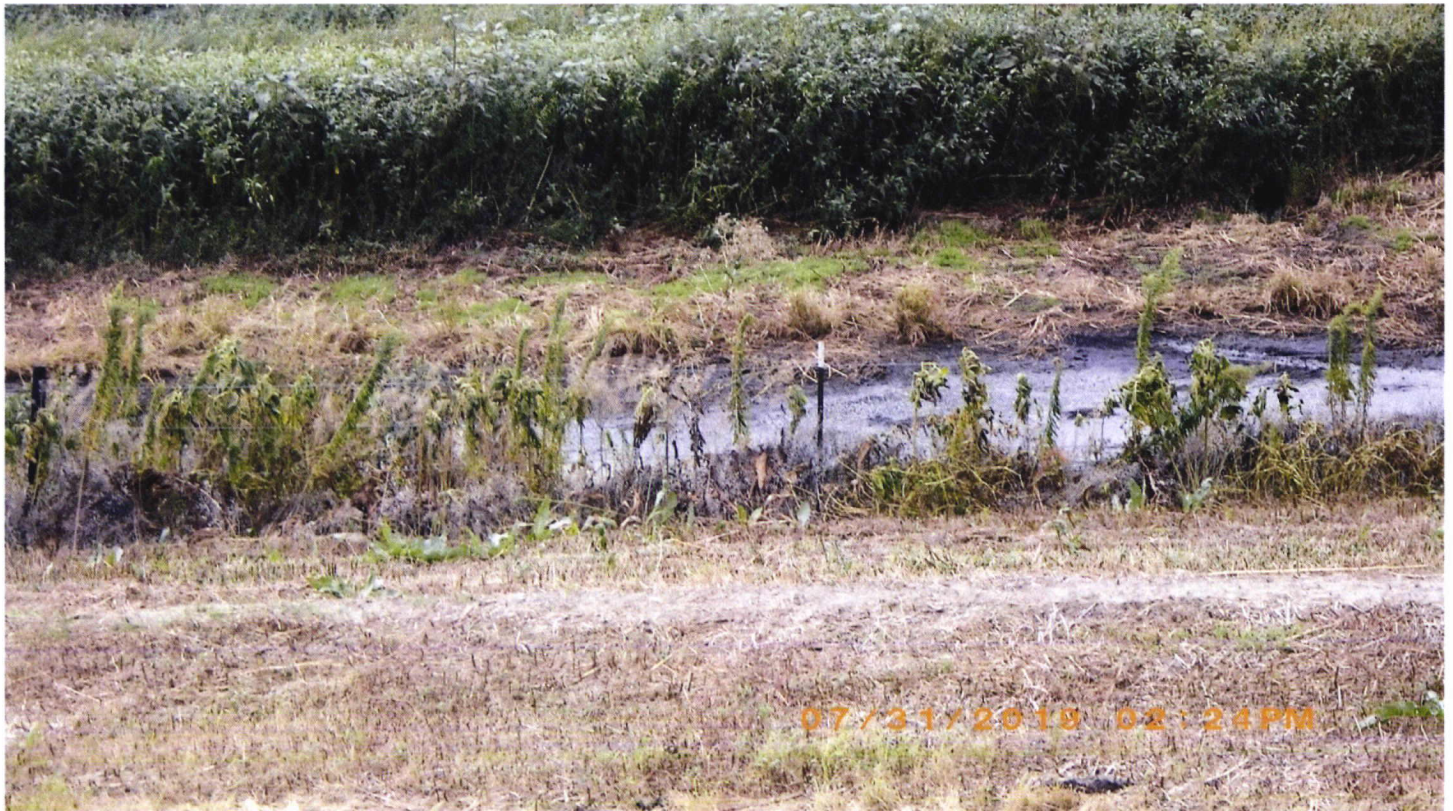
Photo 54

Description: Drainage way to the east from the west cake storage area flowing to the southwest corner of the southeast lagoon. The distressed vegetation indicates that there is constant drainage for the wet cake storage area.

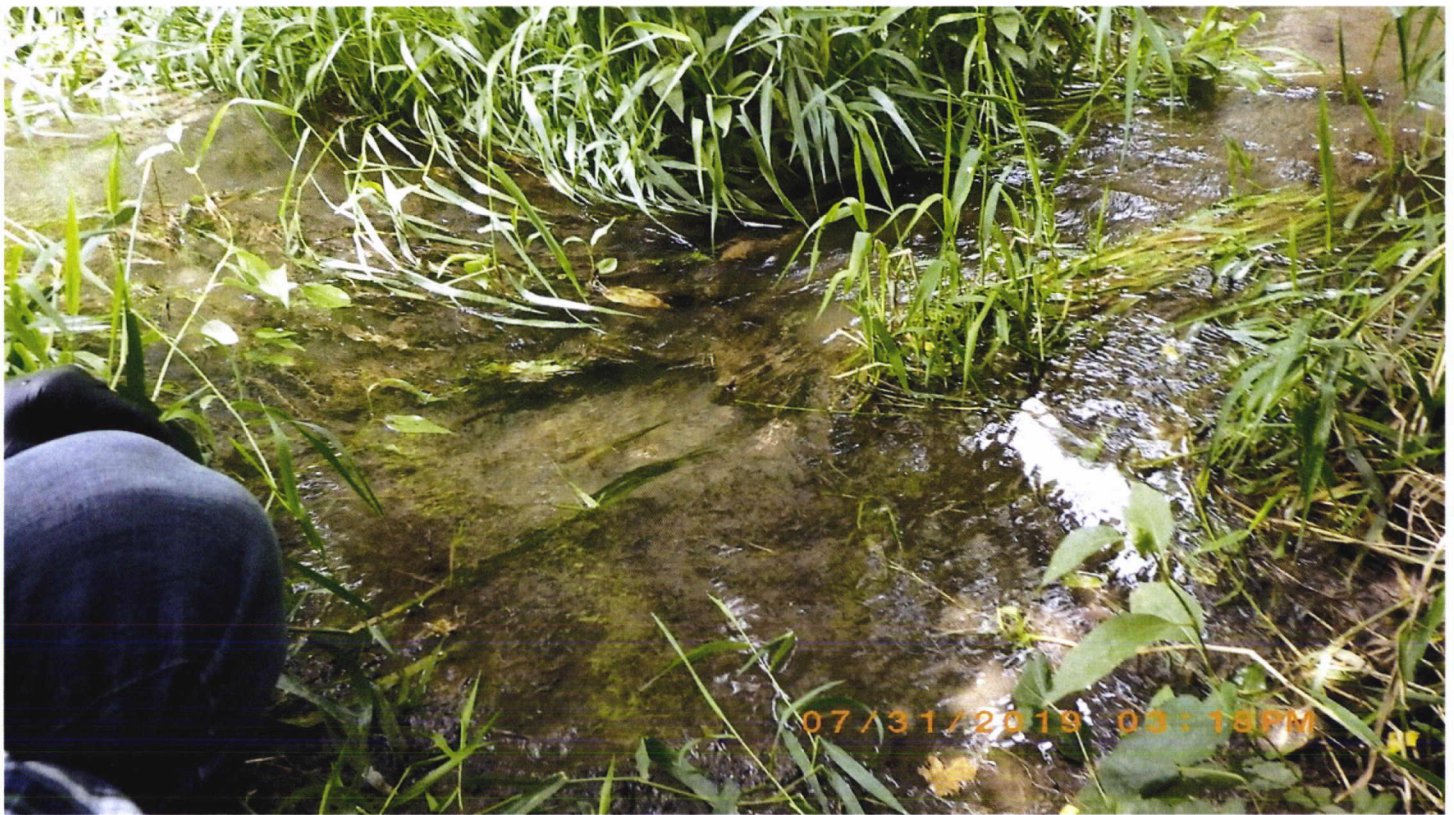
Photo 56

OA7 is the culmination of OA5 and OA6. The collection site is non-storm water runoff from the cooling water tower. We collected samples for benchmark requirements in accordance with Subsector C5. Industrial Organic Chemicals in the facility SWPPP. The collection site is approximately 2 foot upstream from the main current, and is a brown greenish color, which contains filamentous bacteria (Photo 55). According to the ISW permit, the facility samples for total suspended solids, chemical oxygen demand and ammonia. Next, we collected and analyzed the same parameters from the outfall 001 as described in the facility SWPPP. The storm water current is faster, clear, and cold (Map 3-labelled current outfall 001, (Photo 57). All samples were collected and preserved according to DEPARTMENT standard sampling procedures. We then placed on ice for transport, and delivered to the State of Nebraska HHS Lab for analysis.

Description: Non-storm water runoff being collected from an outfall that is receiving runoff from the cooling tower discharge. The water is being sampled for the benchmark requirements for the facility and is being sampled approximately 2' upstream from the main current.
