Facility: AltEn  
IIS: 84069  
PCS: NE0137634

Mark Pomajzl  
4/28/2021

### Site Visit Check list

Facility Name/ Project Name: AltEn LLC

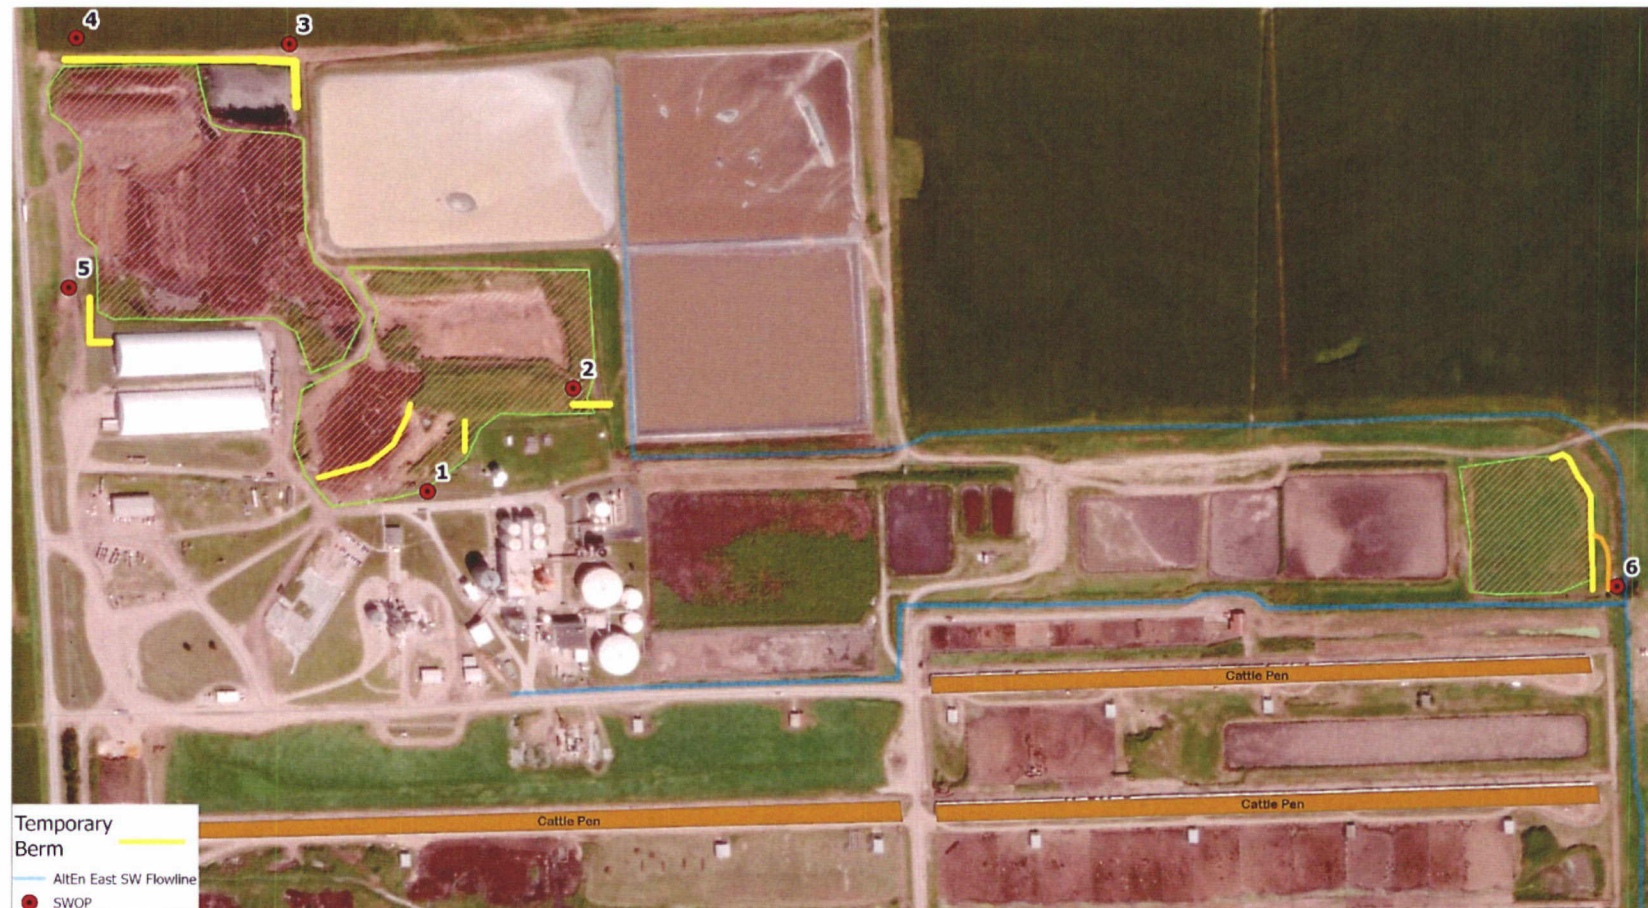
## AltEn LLC - Storm Water Temporary BMP Check Map

- Area 1 contains two berms. The east berm has been expanded to prevent parking lot water from entering the berm area. I observed no seepage from the east or west berm.
- Areas 2, 3, 4 and 5 show no seepage.
- Area 6 shows signs of seepage along the northwest corner of the pile. There is no berm in place to contain runoff.

Area 6 - Seepage observed on the Northwest Corner of the pile - Beam is needed to prevent stormwater discharge
