Nebraska Department of Environment and Energy (NDEE)

MEMORANDUM

RE: AltEn, LLC

Subject: Site Visit Report (Stormwater only)

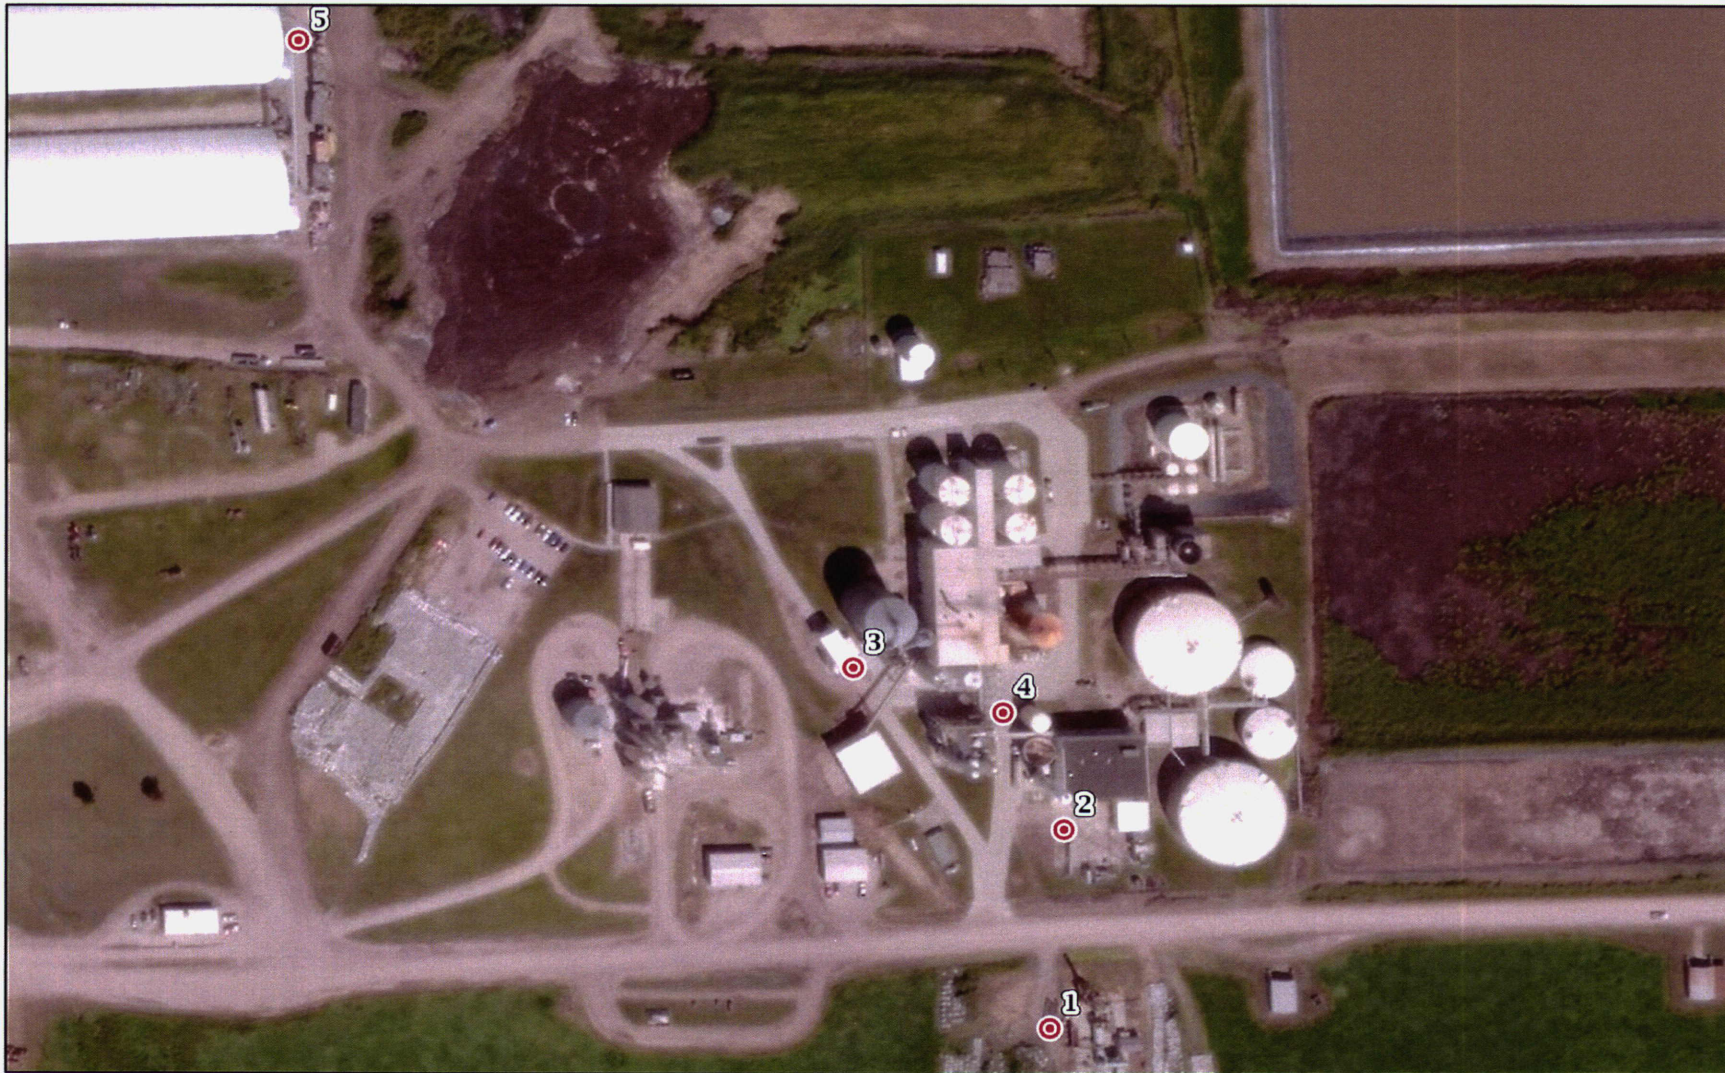
AltEn LLC February 1, 2021 Site Visit Map 1

Observation Area 1 (OA1), Map 1

OA1 is the Biochar Process, which is located south of the main ethanol production plant. The area west of the Biochar is used to store super sacks of process biochar, photos 1 and 2. In accordance with the storm water pollution prevention plan (SWPPP), the facility installed a silt fence around the Biochar Process, photos 3 and 4.

Observation Area 2 (OA2), Map 1

OA2 is north of the Biochar Process. There are unlabeled empty chemical totes stored in this area. Mr. Peterson stated that they are waiting on vendor pick up. It is unknown how much residual chemical is contained in these totes and if they are leaking. There is evidence of track out of mud from this area, which could contain residual chemical, photo 5.

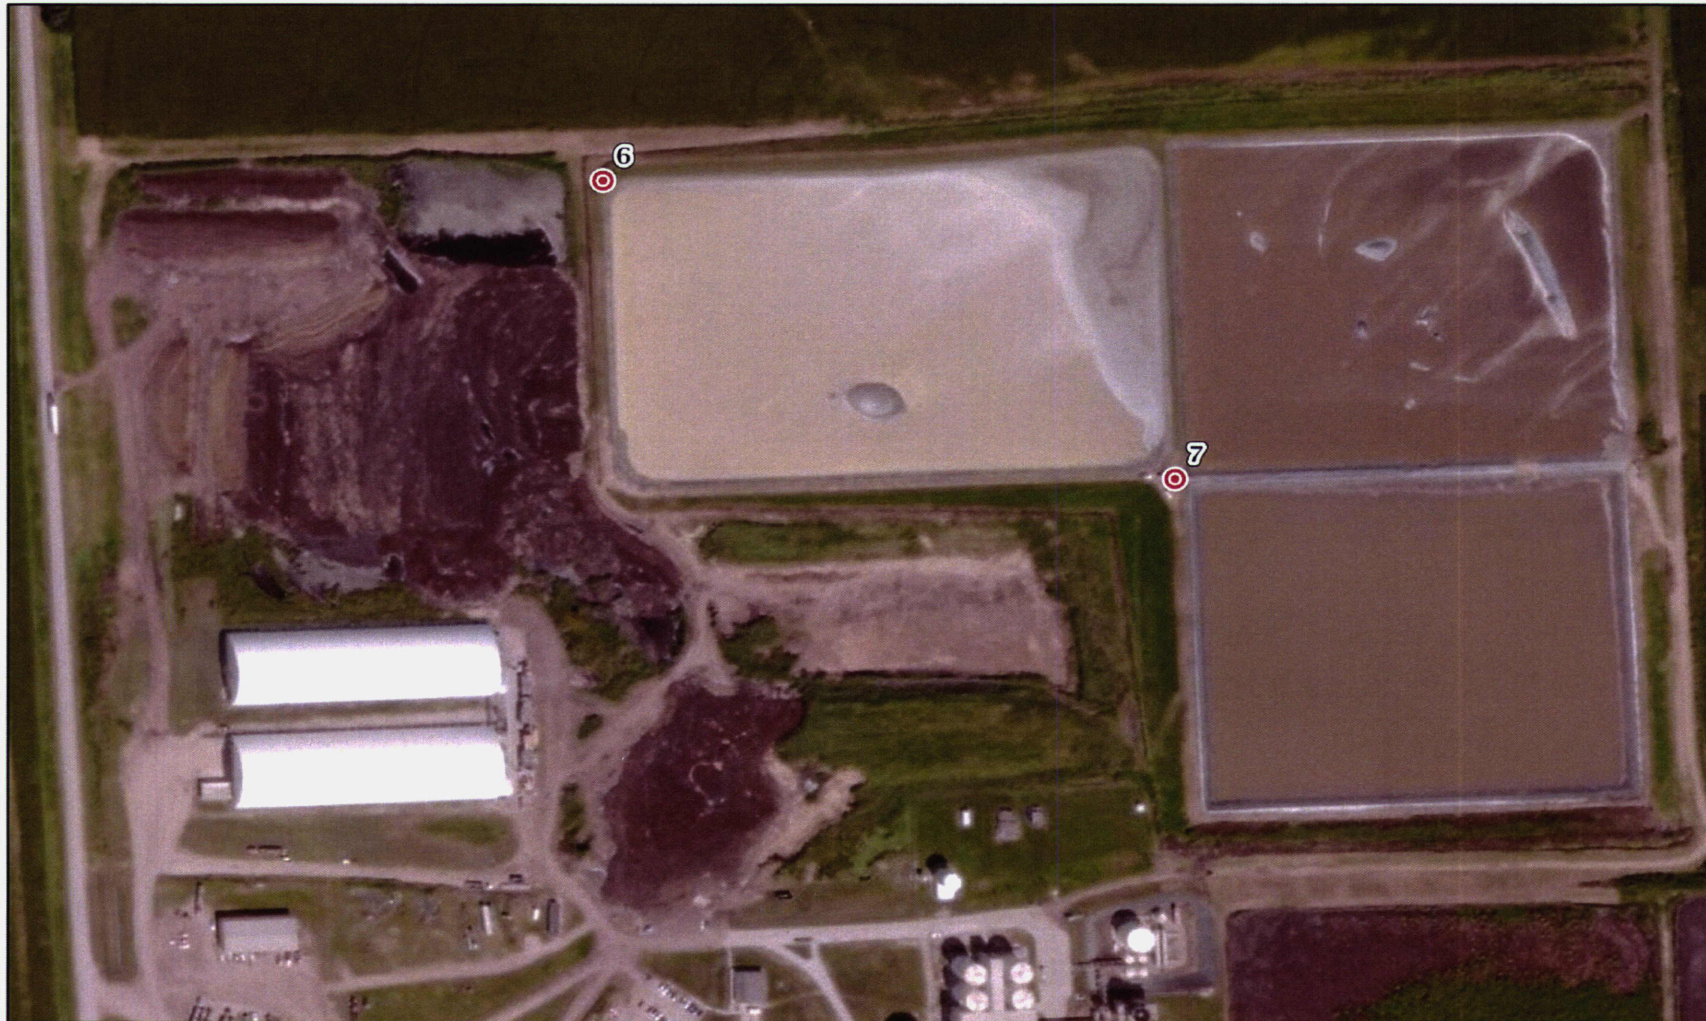
AltEn LLC February 1, 2021 Site Visit Map 2

Observation Area 6 (OA6), Map 2
