RE: ALT EN LLC
MEAD, NEBRASKA

NDEE FAC ID: 84069

PROGRAM ID: 021221-NH-0845

DATE: February 19, 2021

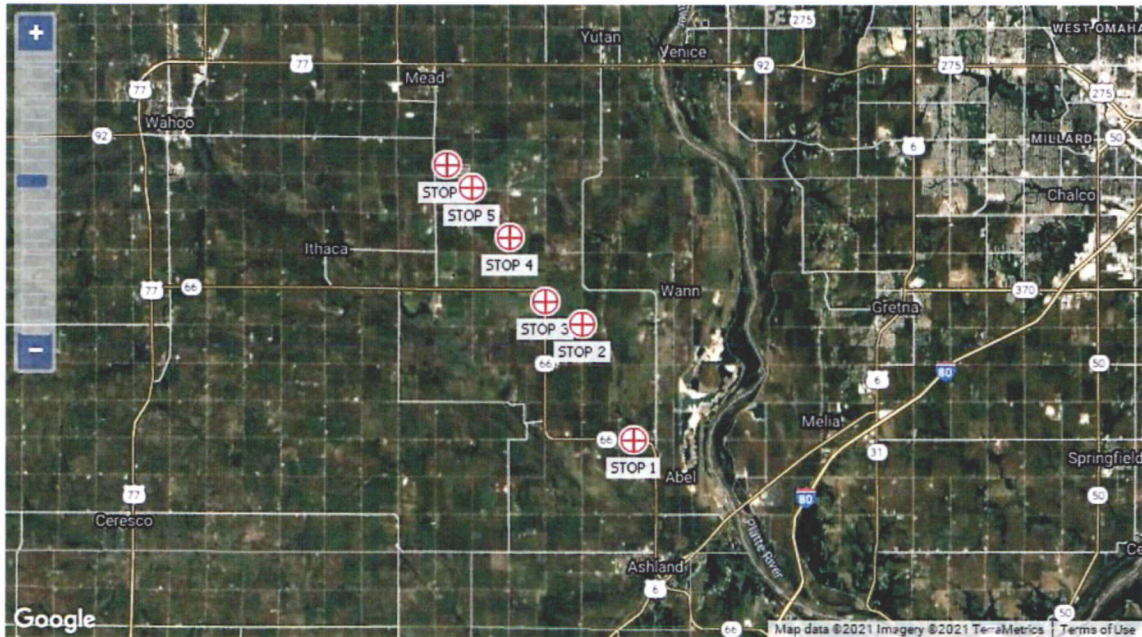
ALTEN SITUATIONAL AWARENESS (FEB 2021)

- DAILY TRIPS (One Person) - This could be twice per day as things warm up.
- 6 Stops
- Visual Observations recorded
- Immediate Notification/Action if changes are observed.
 - Sampling
 - Initiate a Response Contractor
- Record observations on a custom/standard form.
