MEMORANDUM

DATE: February 22, 2021
TO: AltEn
THRU: Brad Pracheil
FROM: Josh Wilhelm
RE: University of Nebraska Lincoln, Agricultural Research and Development Center Site Visit

FACILITY ID: 84069

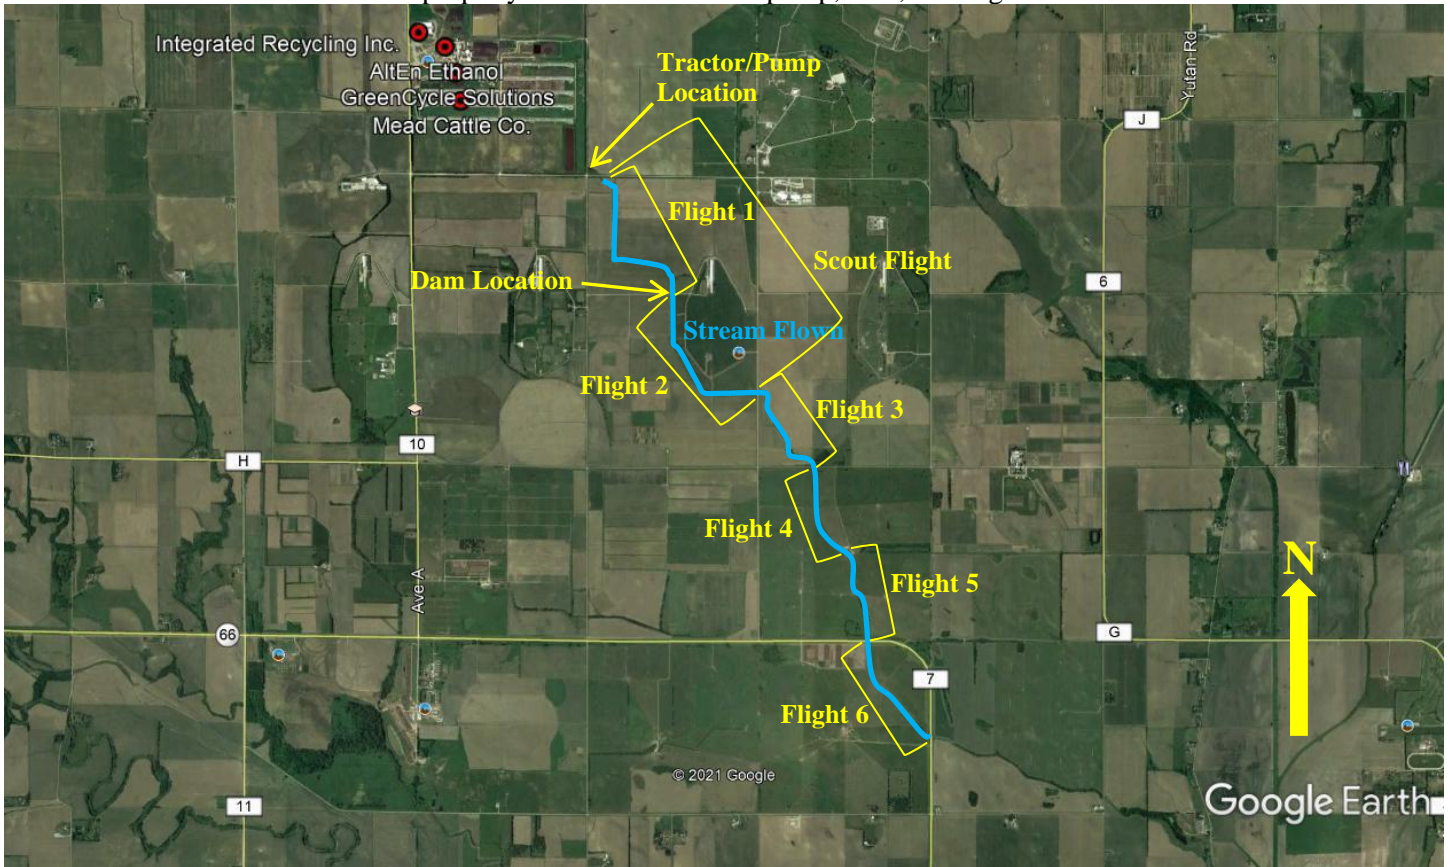
Arial image of UNL property flown by NDEE staff 2/18/2021

The UNL property and locations of the pump, dam, and flight locations.

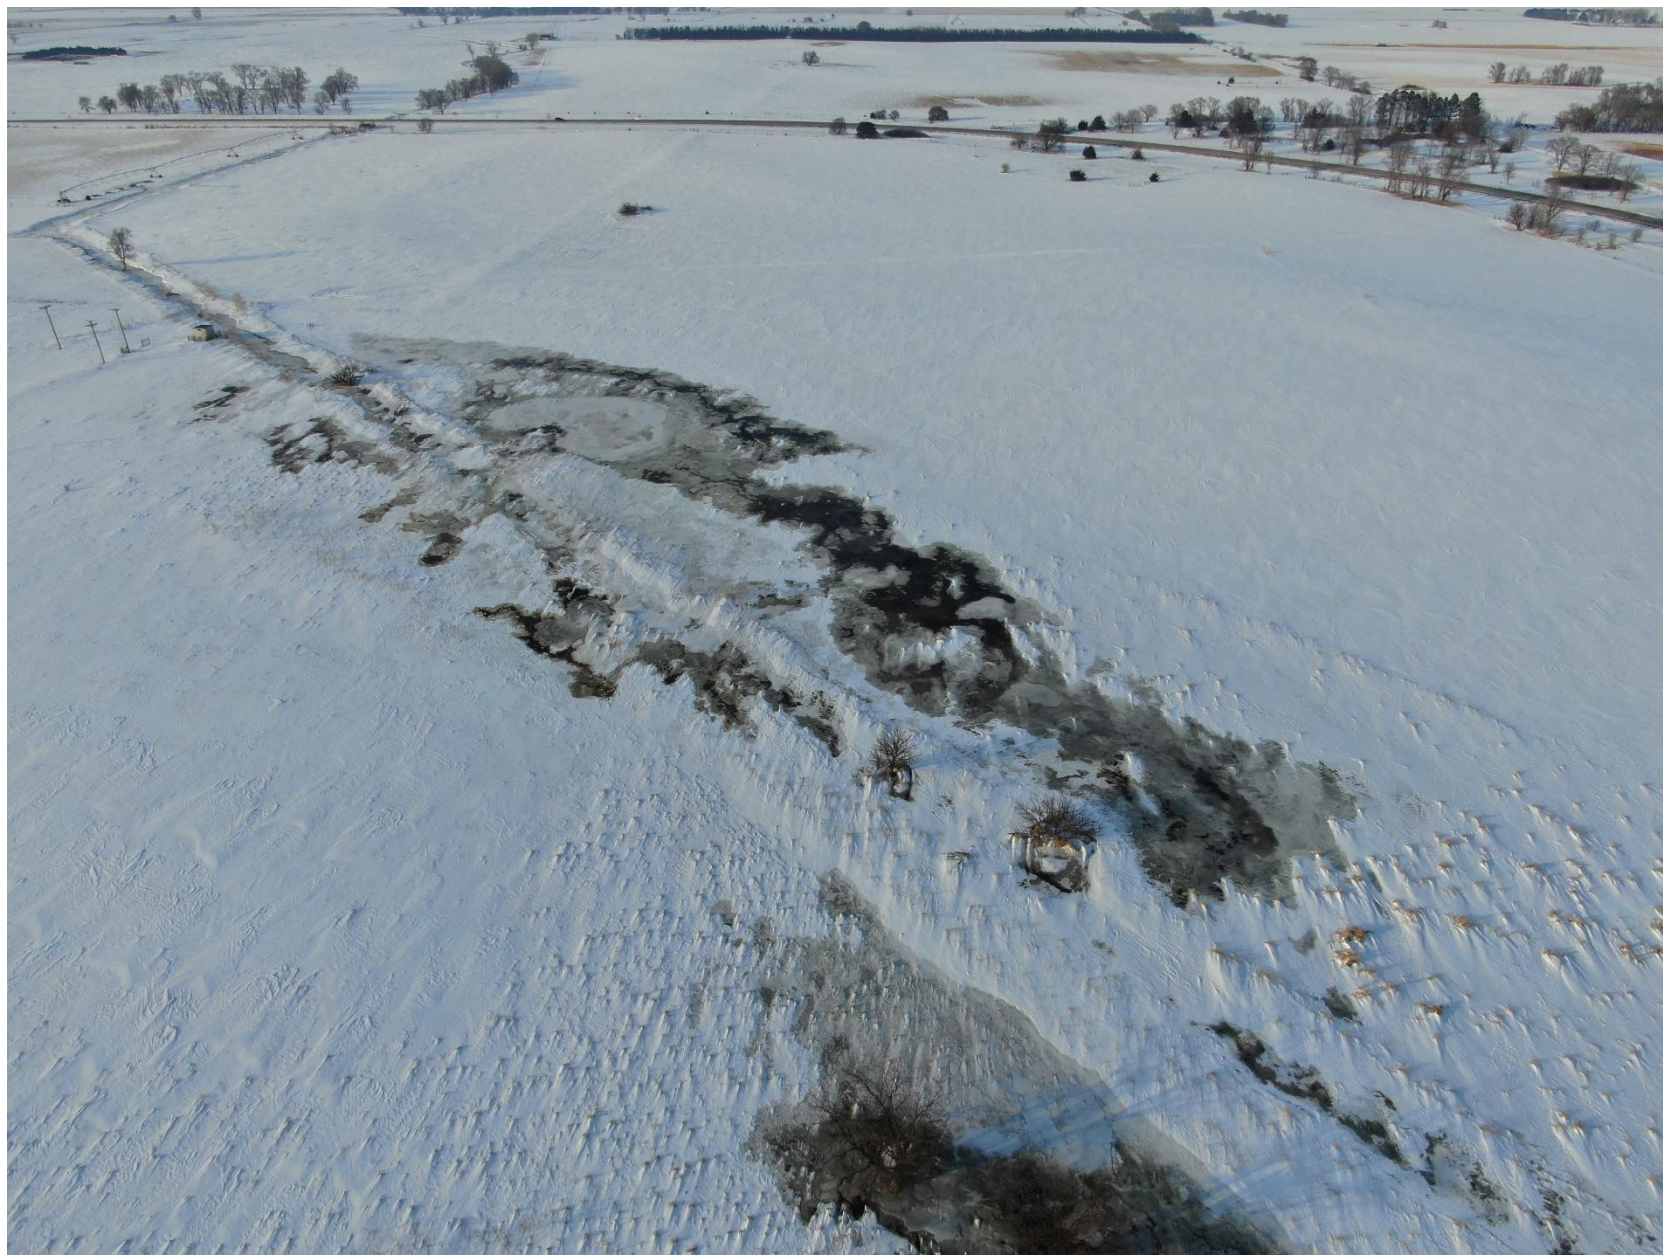
Downstream of road crossing near UNL dam site – 2/19/2021

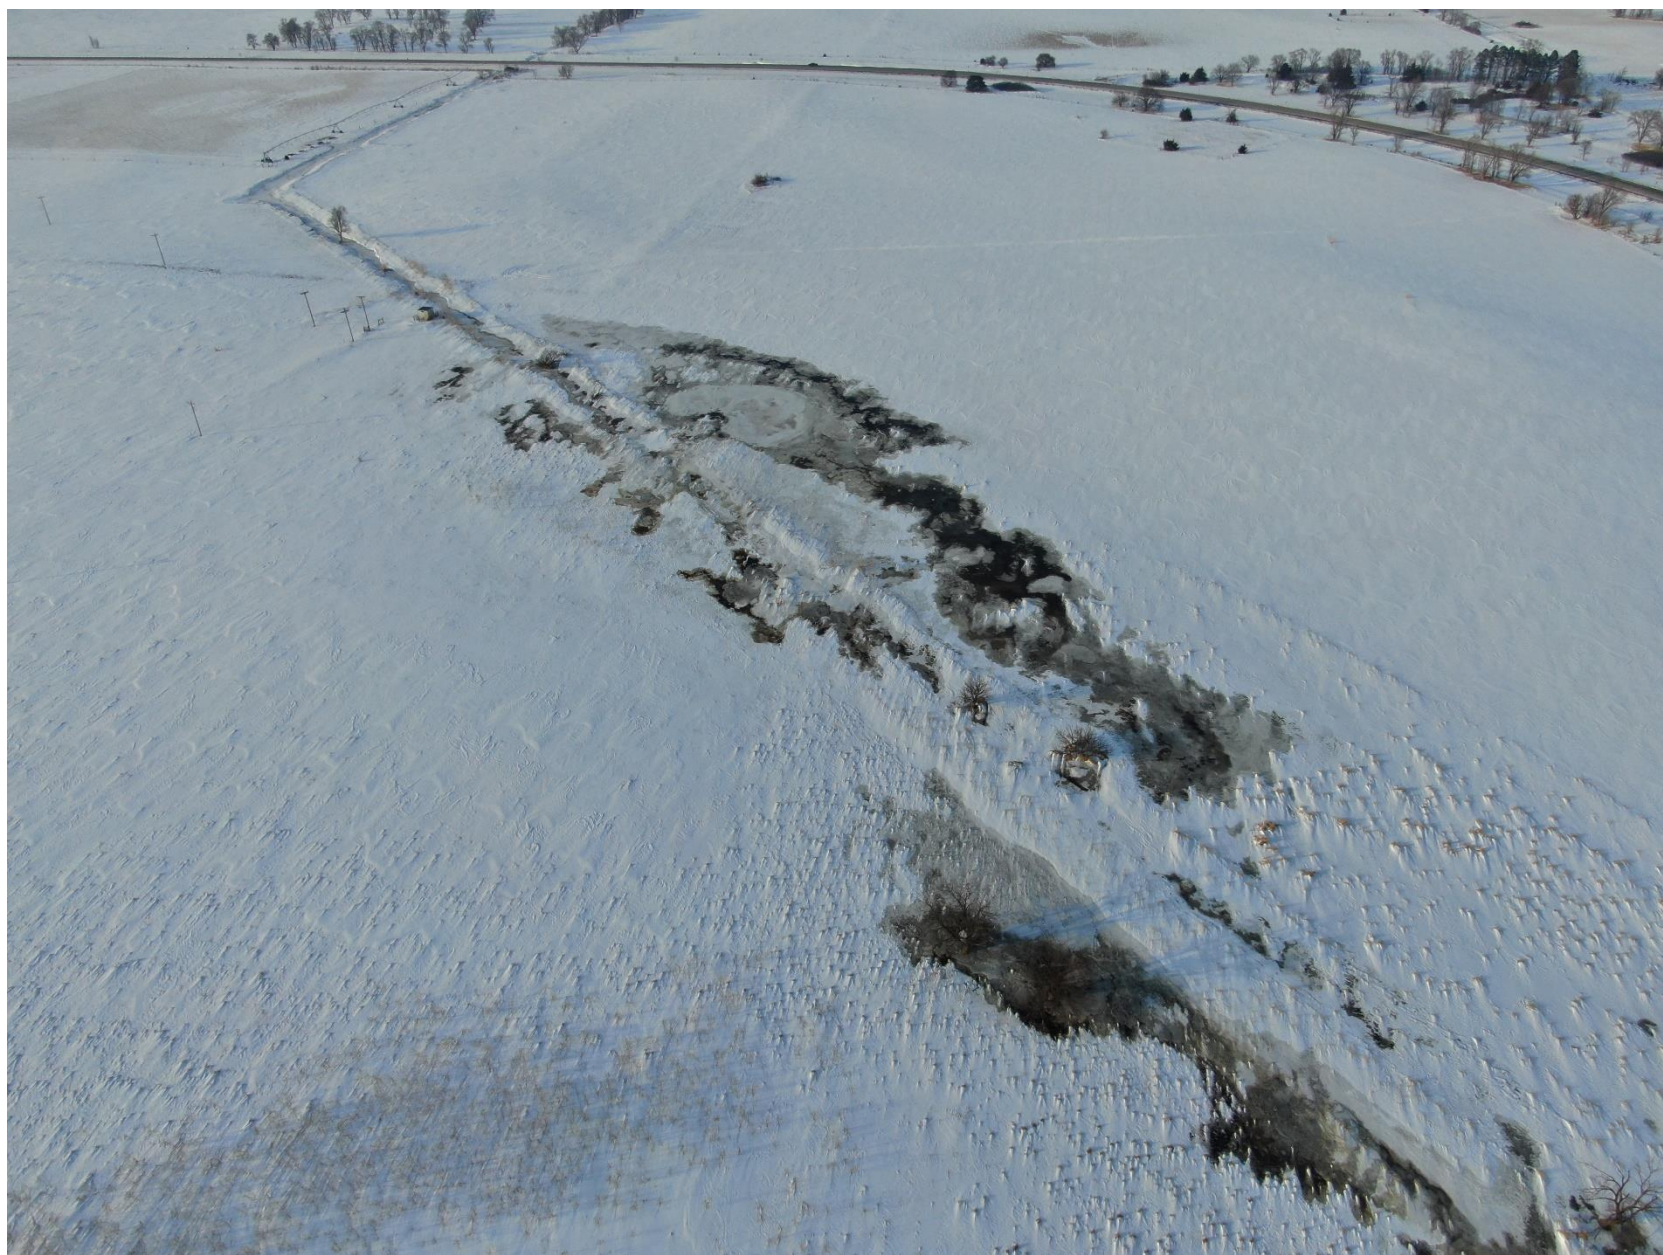
Staining in ice and on top of ice south of dam and road crossing on UNL property.

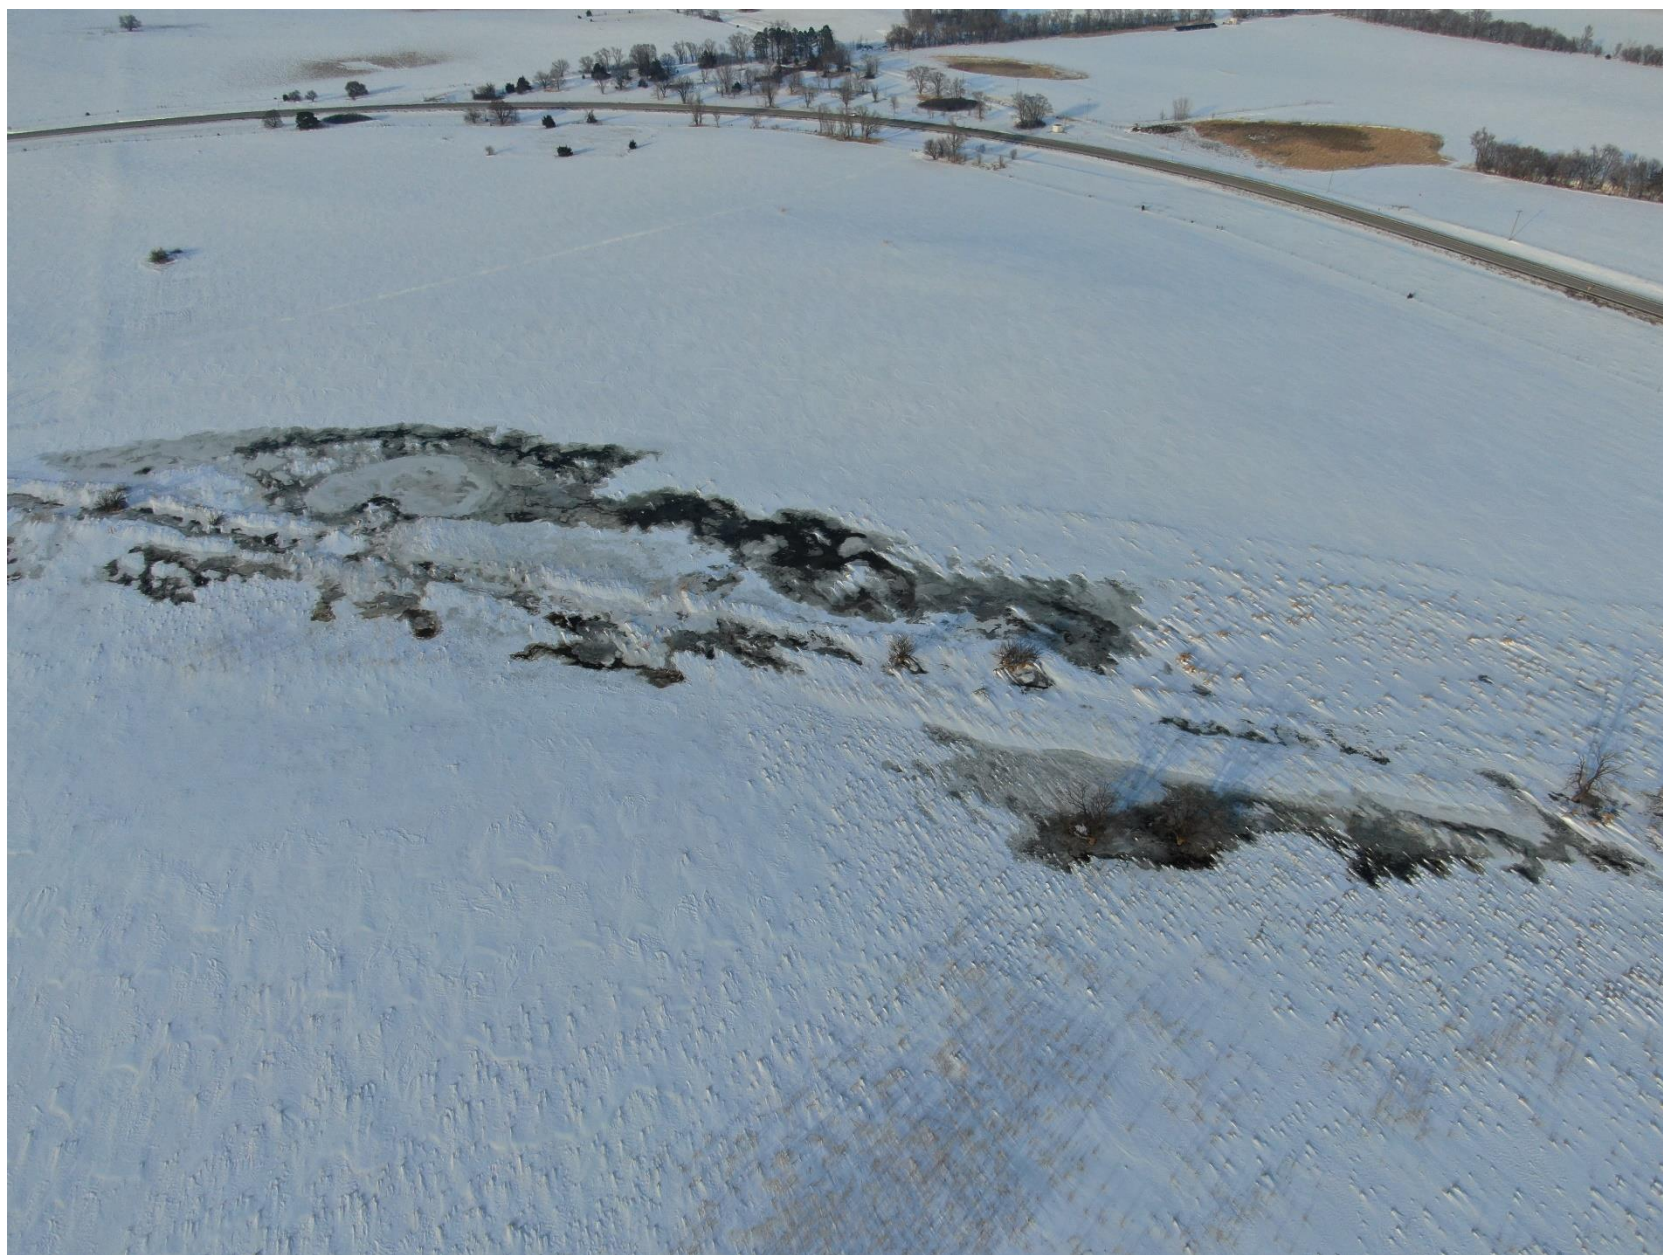
View of dam from road crossing on ULN property with visible staining in ice and on top of ice.

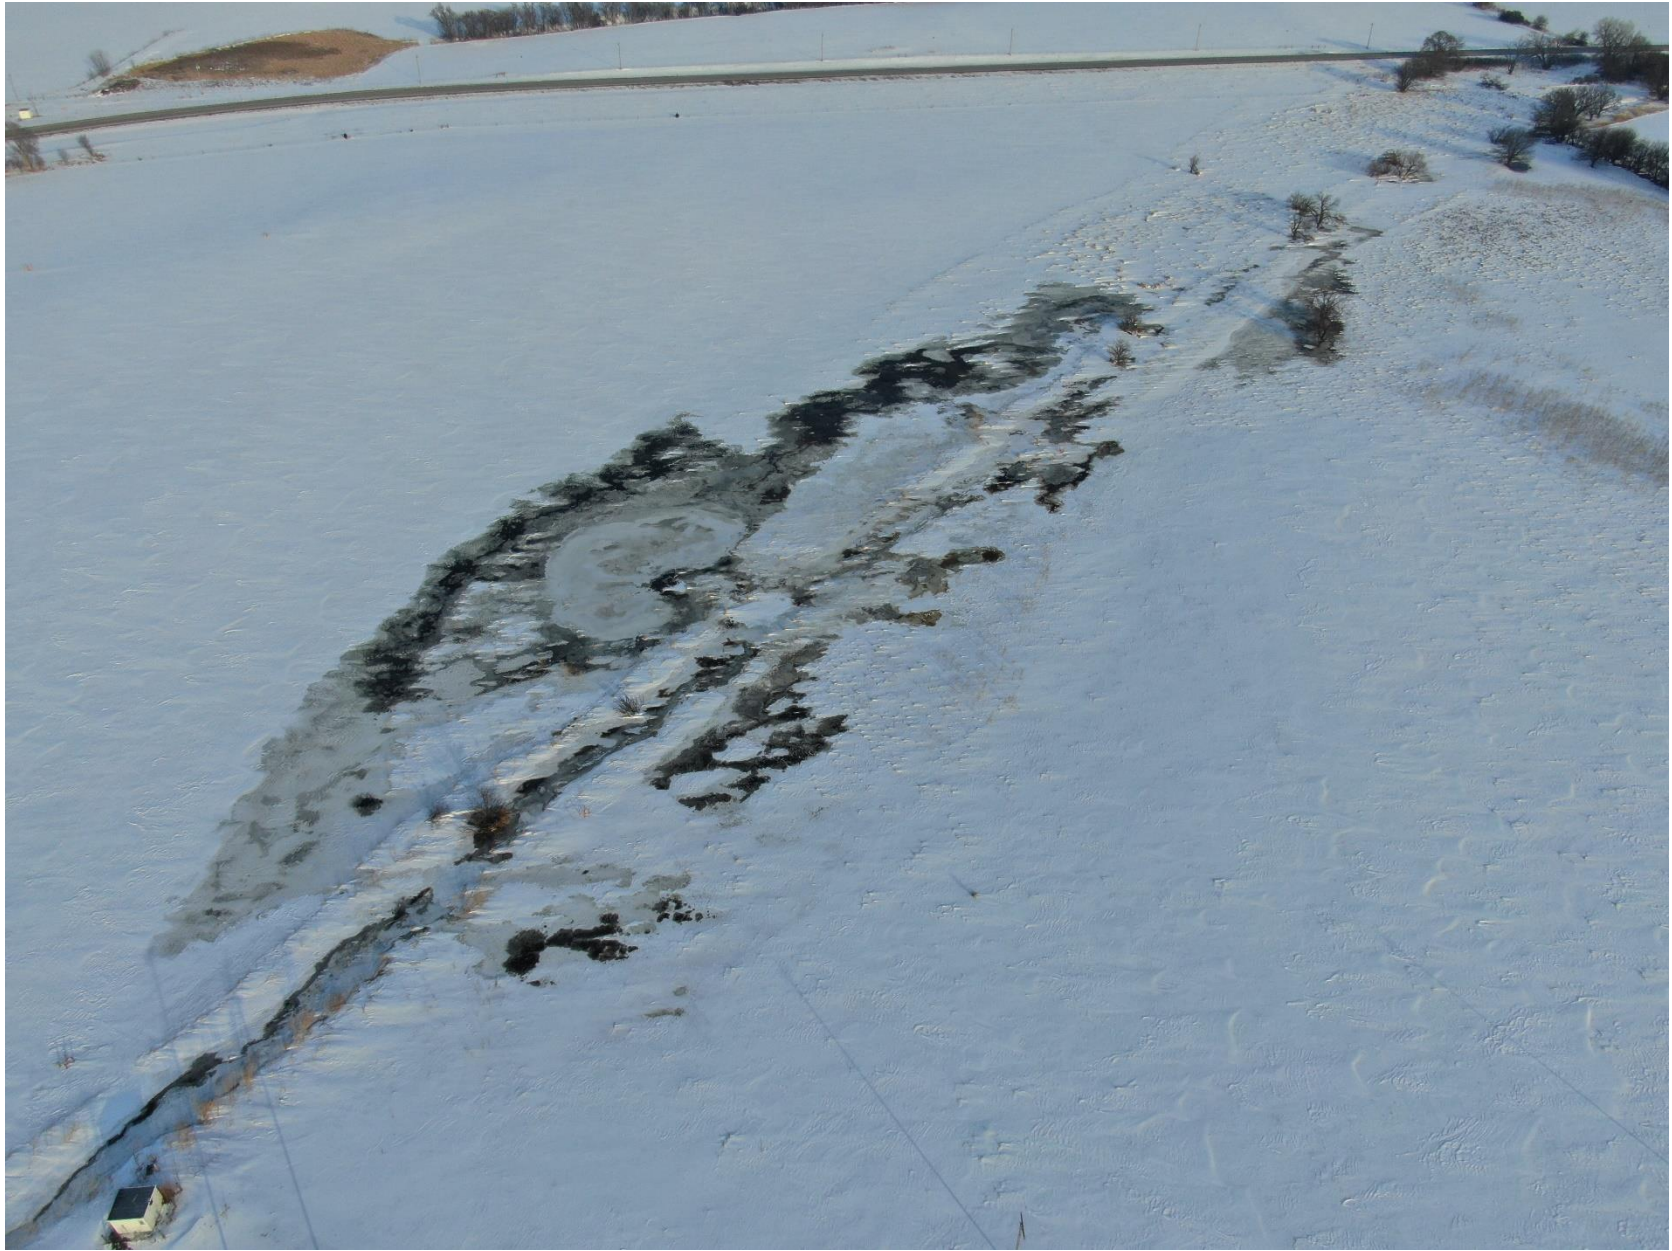
Upstream side of dam on ULN property with visible staining in ice and on top of ice. No sign of liquids flowing or backing up behind the dam were observed.

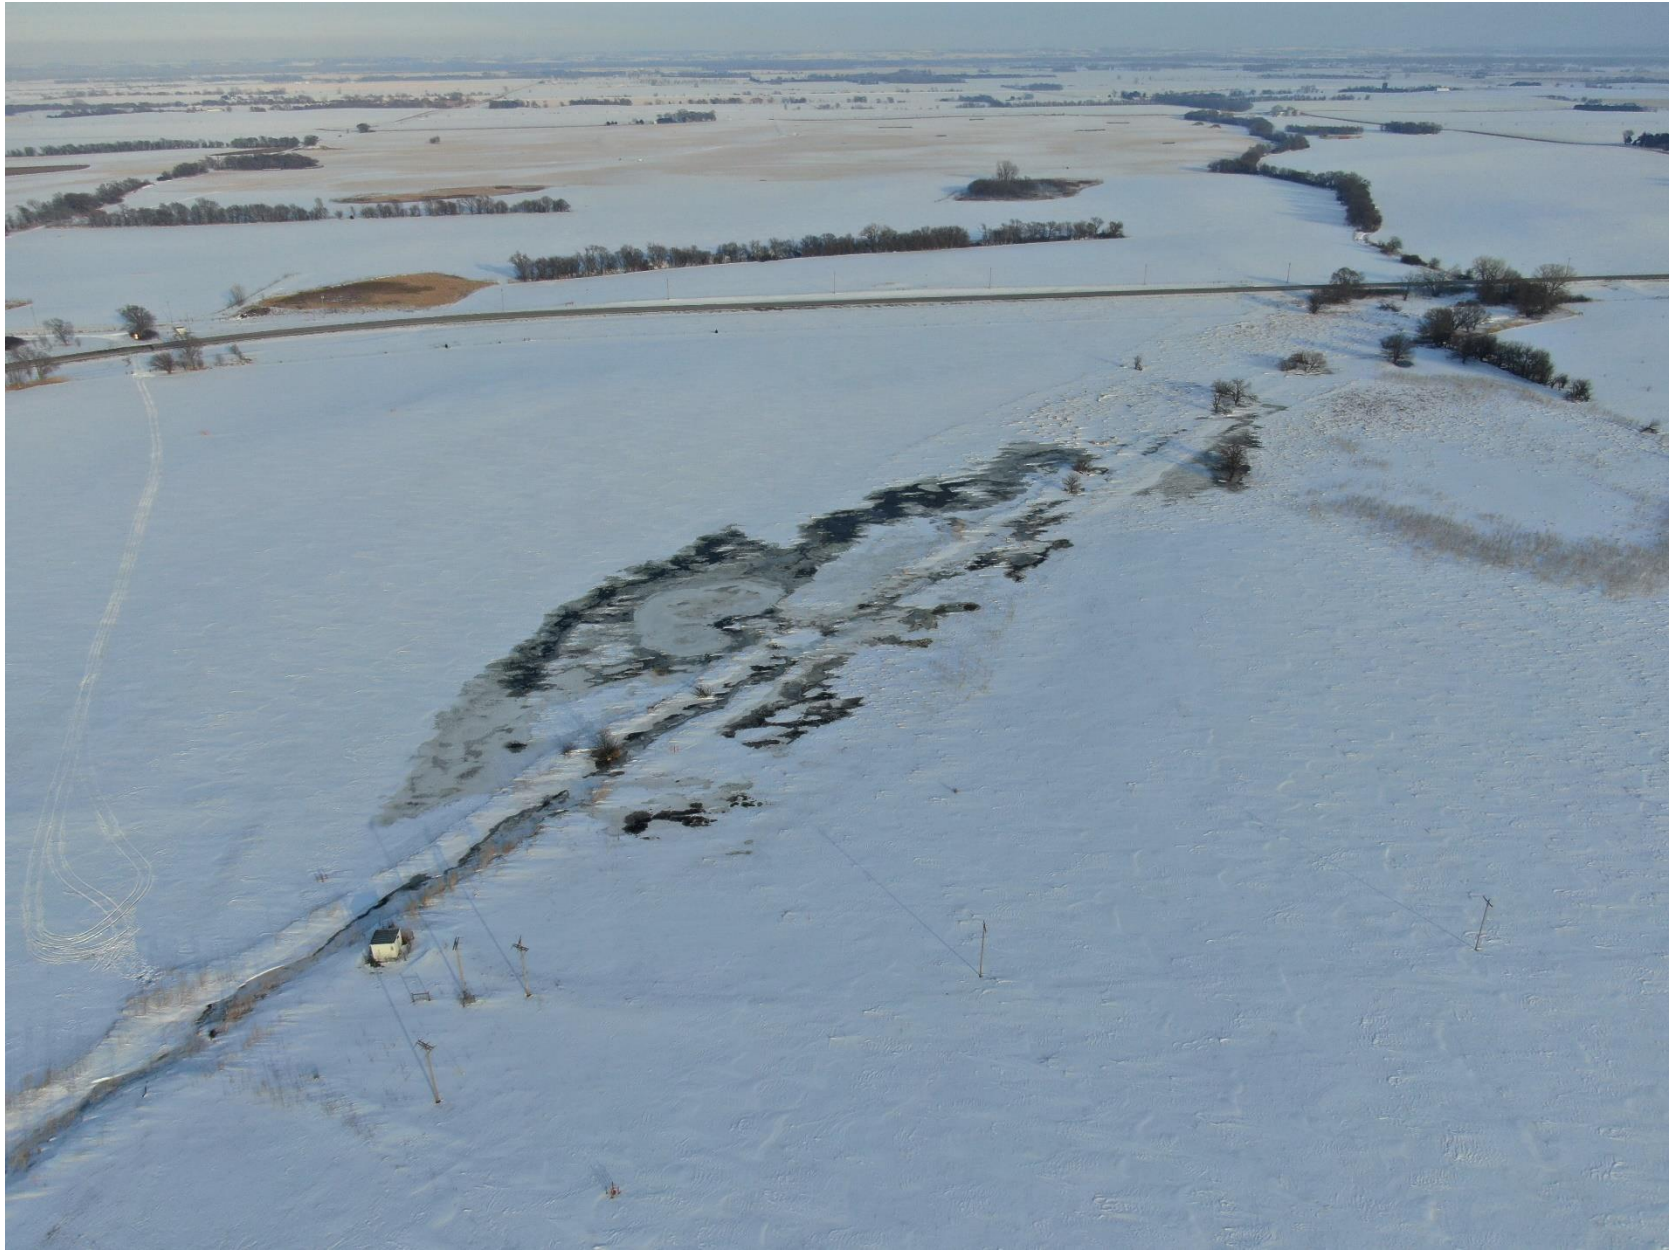
Downstream side of dam on ULN property with visible staining in ice and on top of ice. No signs of flowing liquids were observed below the dam.
