From: Pomajzl, Mark
Sent: Thursday, March 18, 2021 2:28 PM
To: Pracheil, Brad; Anderson, Reuel; Ugai, Susan; Stoll, Hillary; Valentine, Kara; Goans, Steve; Windhorst, Jason
Subject: AltEn Site visit (Wednesday)
Attachments: AltEn daily (wednesday).docx

Facility: AltEn
IIS: 84069
PCS: NE0137634

Mark Pomajzl
3-17-2021

Site Visit Check list

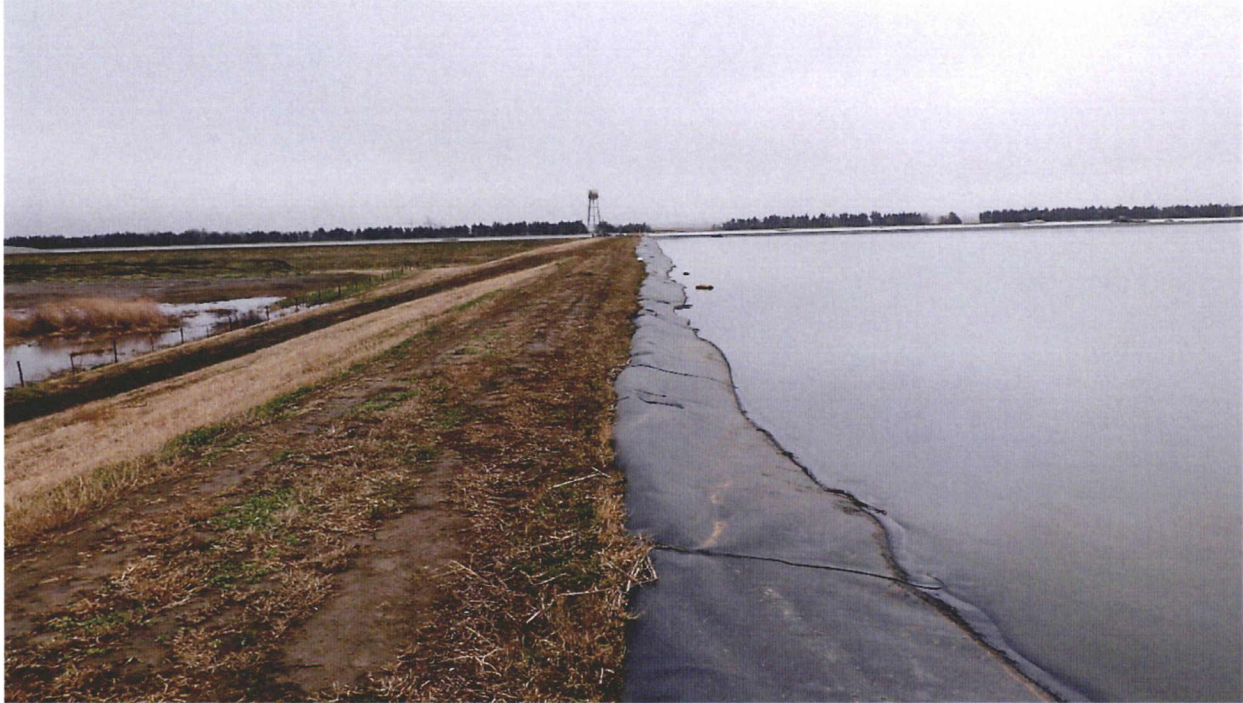
Photo: 9

Description: This photo depicts the south lagoon.

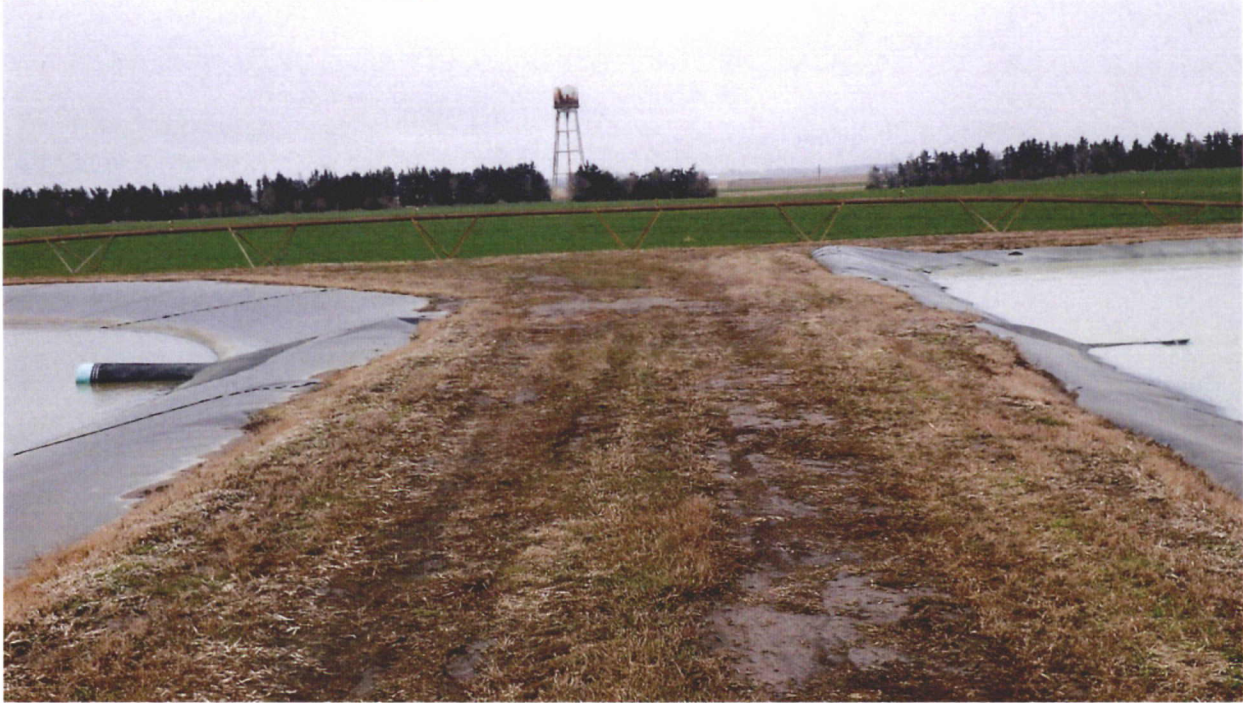
Photo: 15

Description: This photo depicts the lagoon liner and freeboard.

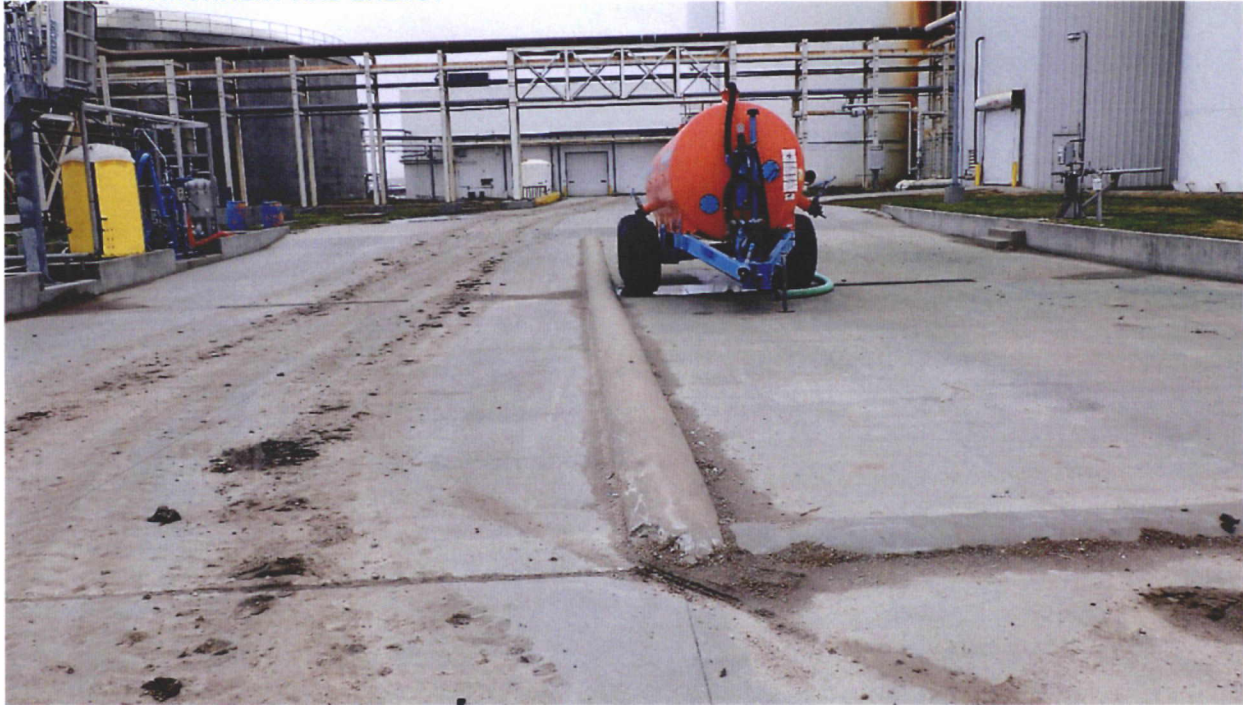
Photo: 18

Description: This photo depicts the lift station. There is very little water in the transfer box at this time. Mr. Peterson stated that storm water is conveyed through this station. Mr. Peterson also stated that one to two thousand gallons of solids from the new treatment system enters this lift station. The lift station pumps directly to the lagoon system.

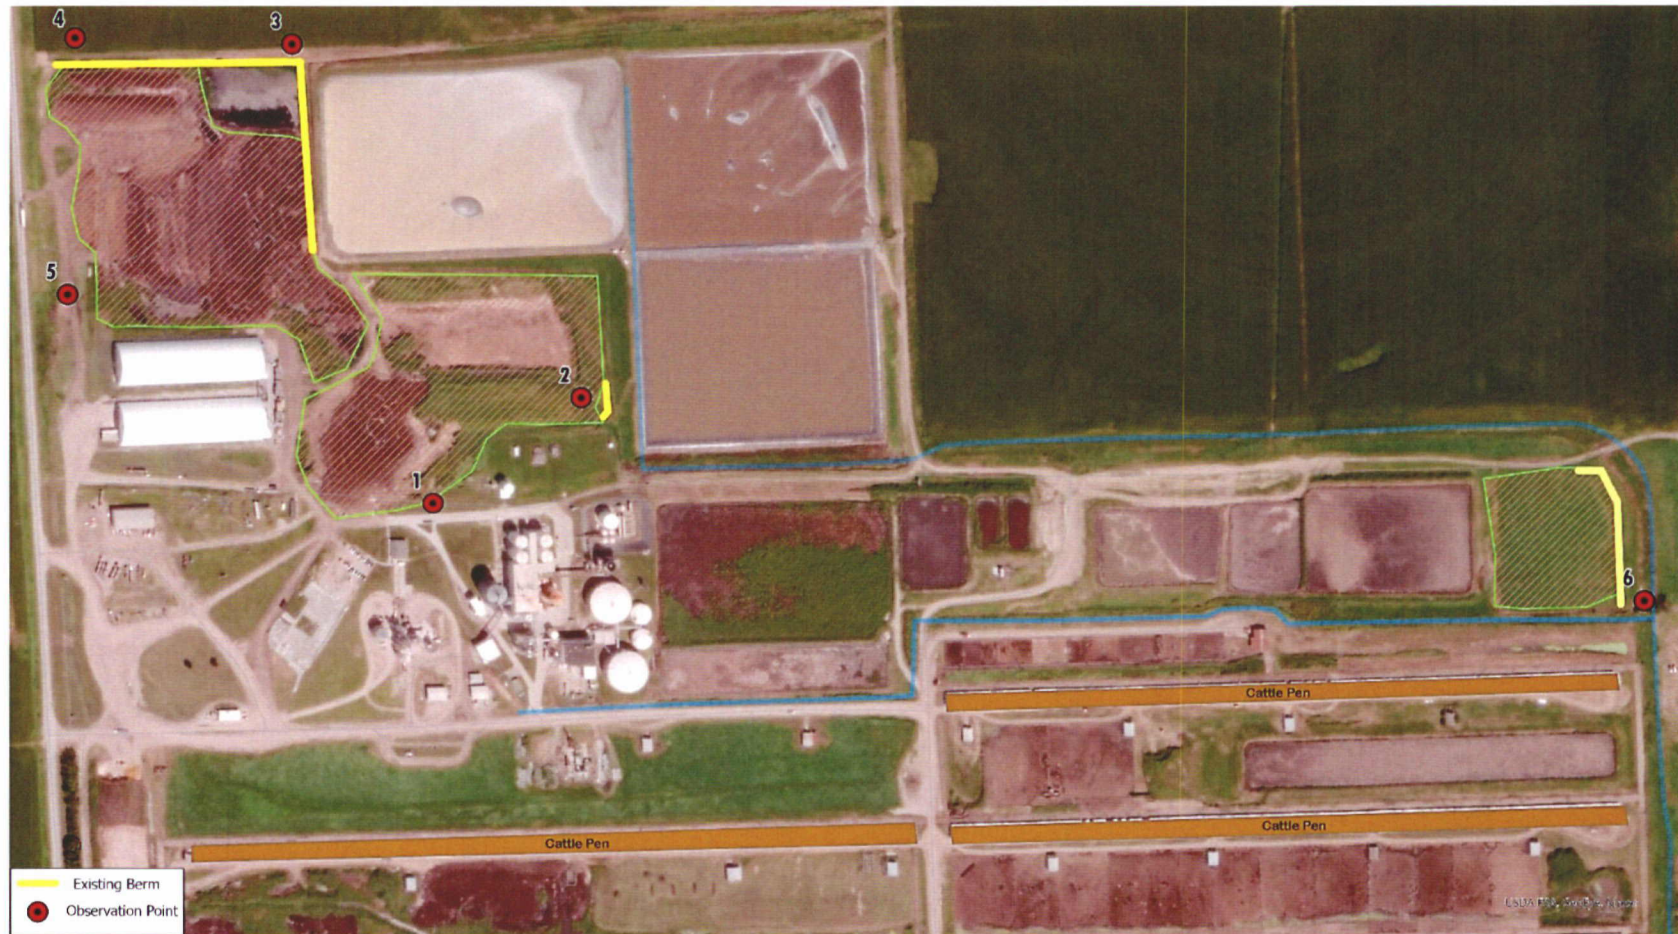
AltEn LLC - Storm Water Temporary BMP Check Map

- The facility has expanded the berm northeast of the administration building.
- The facility expanded the berm near the south lagoon.
- The east wet cake pile berm needs reinforcement. I pointed out the area to Mr. Peterson. Mr. Peterson agreed to add additional material. Mr. Peterson will also begin pumping.
- The facility agreed to continue monitoring the berms and provide daily emails of any changes or repairs.
