BEFORE THE NEBRASKA DEPARTMENT OF ENVIRONMENT AND ENERGY

IN THE MATTER OF	)	
AltEn, LLC,	)	CASE NO. 3546
	)	
FID # 84069	)	EMERGENCY COMPLAINT
	)	AND ORDER
Respondent.	)

Release of Thin Stillage and Cattle Manure from Digester at AltEn LLC, IIS #84069, RA  
#021221-NH-0845

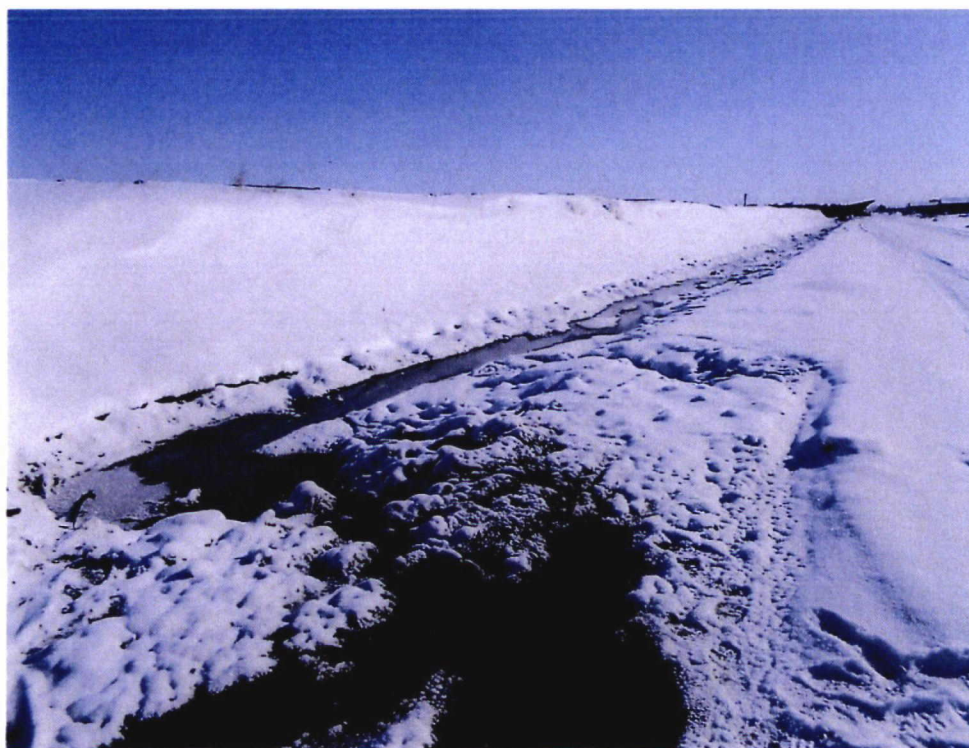
View east from near digester toward road ditch

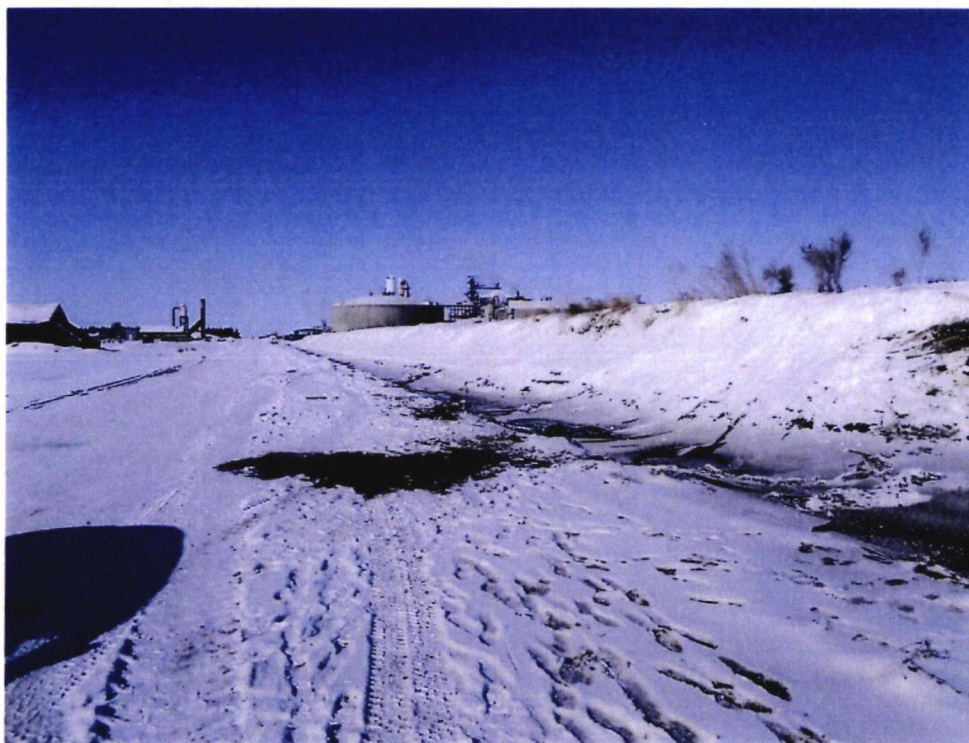
View west of road ditch with digester in background

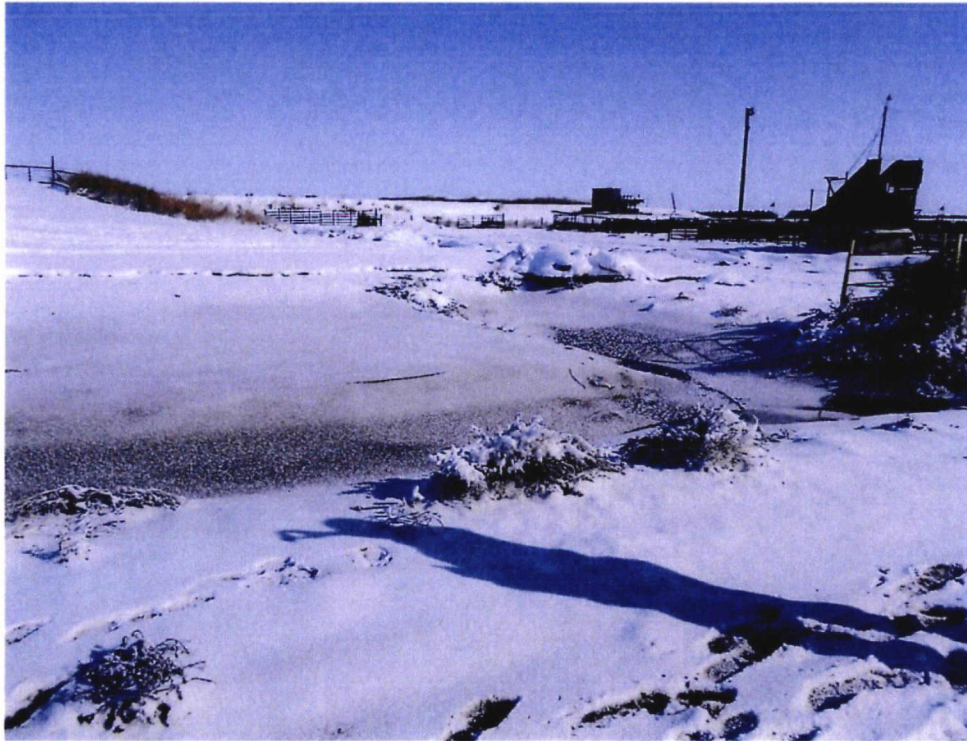
View NE of ditch near Mead Cattle Company

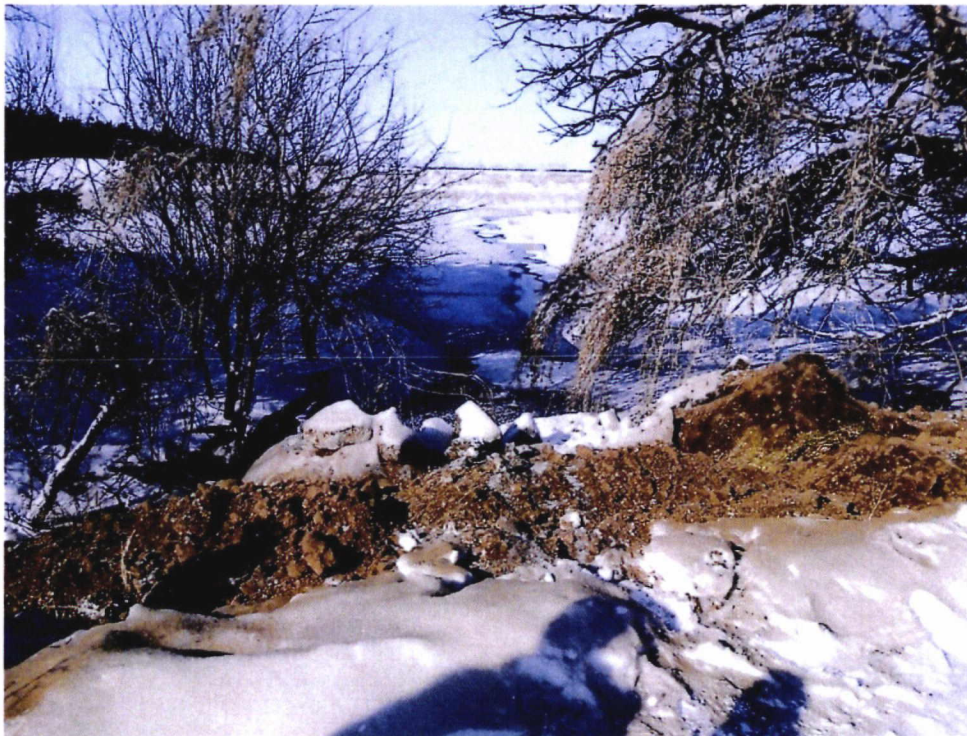
four million gallons of liquid was released to the land surface. The spilled liquid flowed into a ditch and travelled approximately three miles from the source at the time of our response. A dam constructed some time Friday, was ineffective at stopping the flow of spilled liquid. It is not known if the lack of effectiveness of the dam was due to poor construction or failure of the dam due to build-up of hydrostatic pressure.

View WNW of dam upstream of culvert A

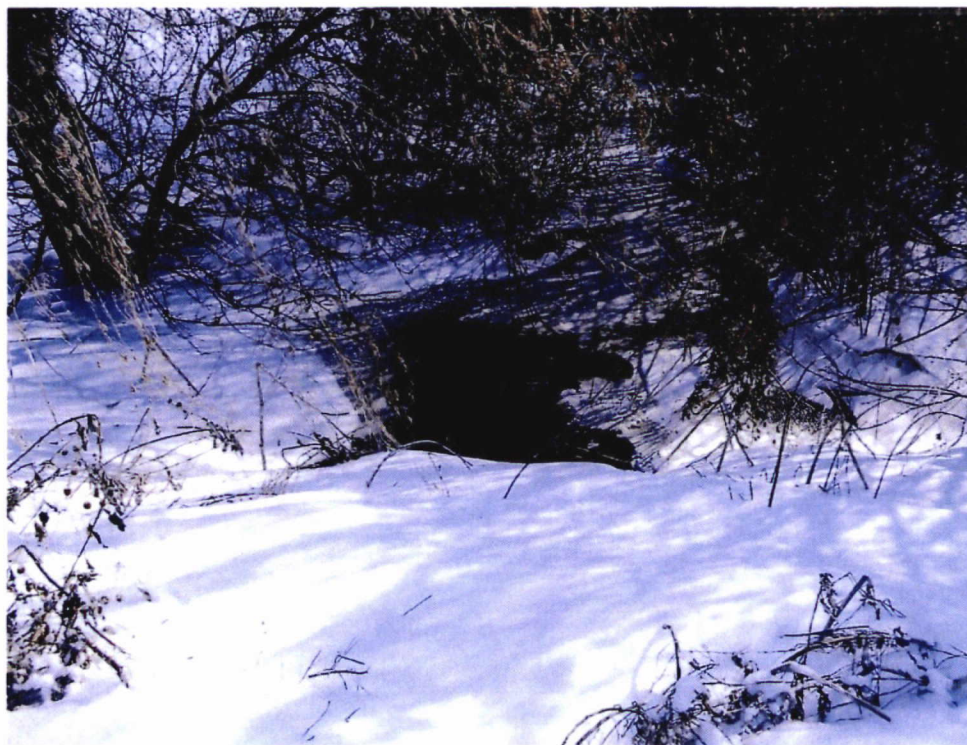
View east of ditch downstream from culvert A

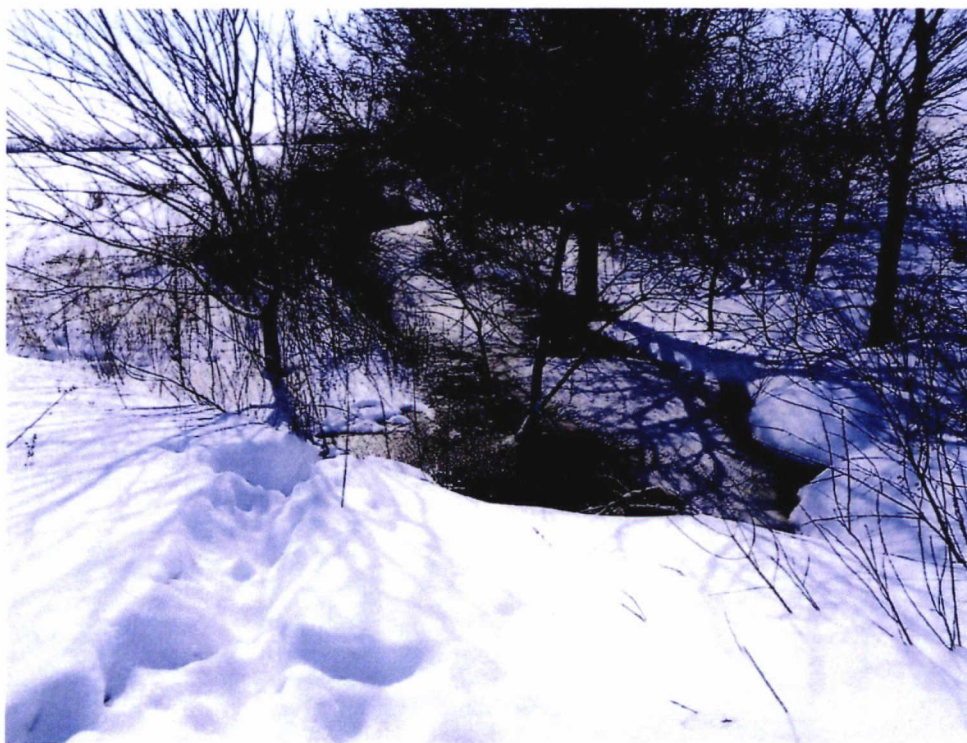
Mark and I proceeded to the next downstream location, depicted as culvert B on the attached Google Earth image, where the ditch intersected with a roadway. We observed liquid flowing through the culvert (see attached photos). Based upon the cold temperatures that we presume would have frozen any pre-existing water and the odor associated with the flowing liquid we observed, that the flowing liquid was likely what had spilled from the digester.

View north of ditch upstream from culvert B

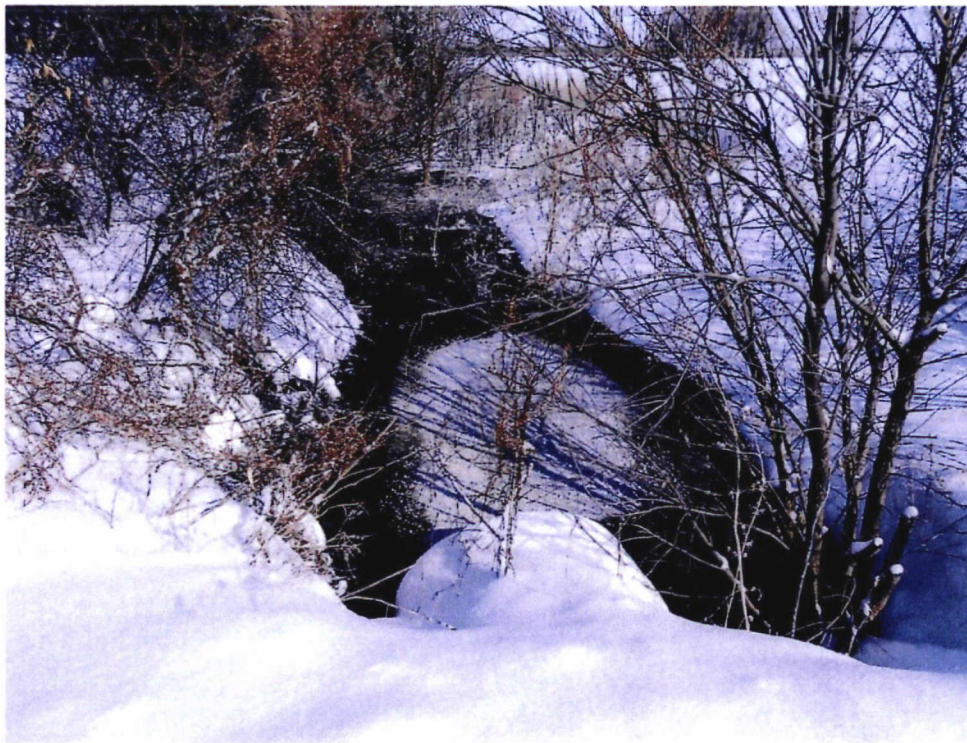
View south of ditch downstream of culvert B

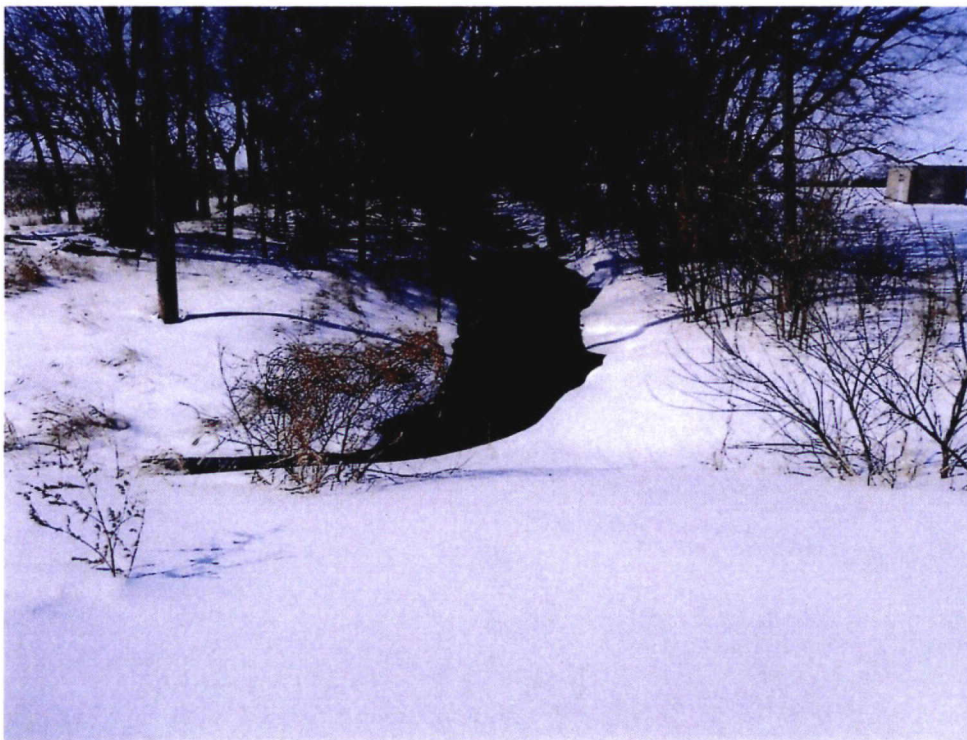
Mark and I proceeded to the location depicted as culvert C on the attached Google Earth image. We observed liquid flowing through the culvert (see attached photos). We proceeded to the location depicted as culvert D on the attached Google Earth image. We observed an inch or two of liquid on top of existing ice and within the snow cover (see attached photos). There was no obvious flow of this liquid. The liquid did exhibit an odor similar to the liquid spilled from the digester.

View north of ditch upstream from culvert C

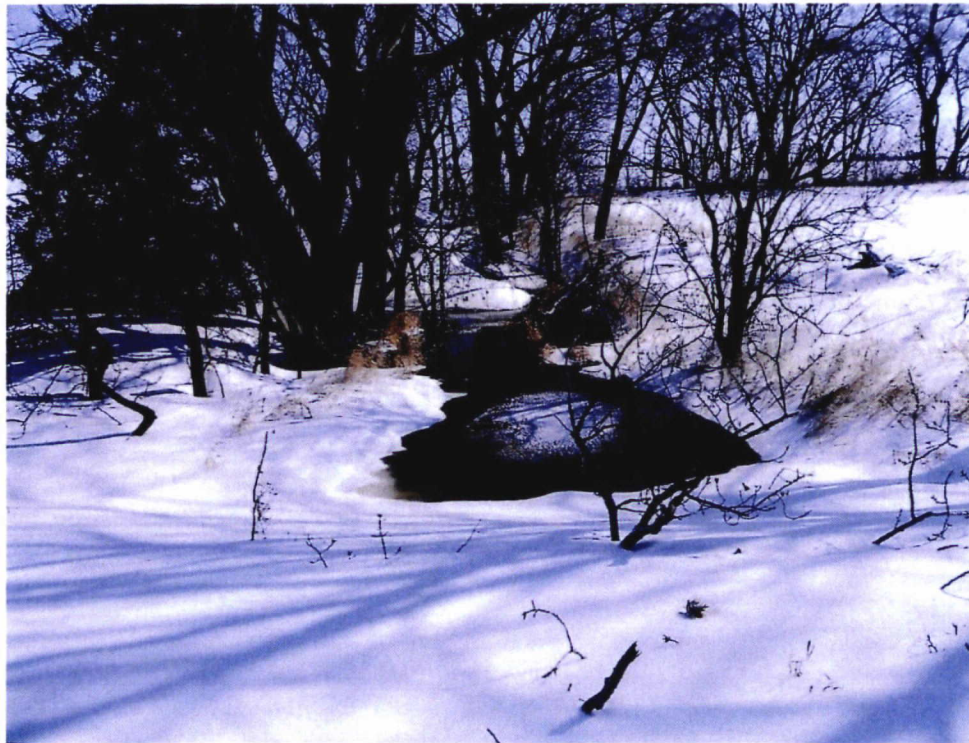
View south of ditch downstream from culvert C

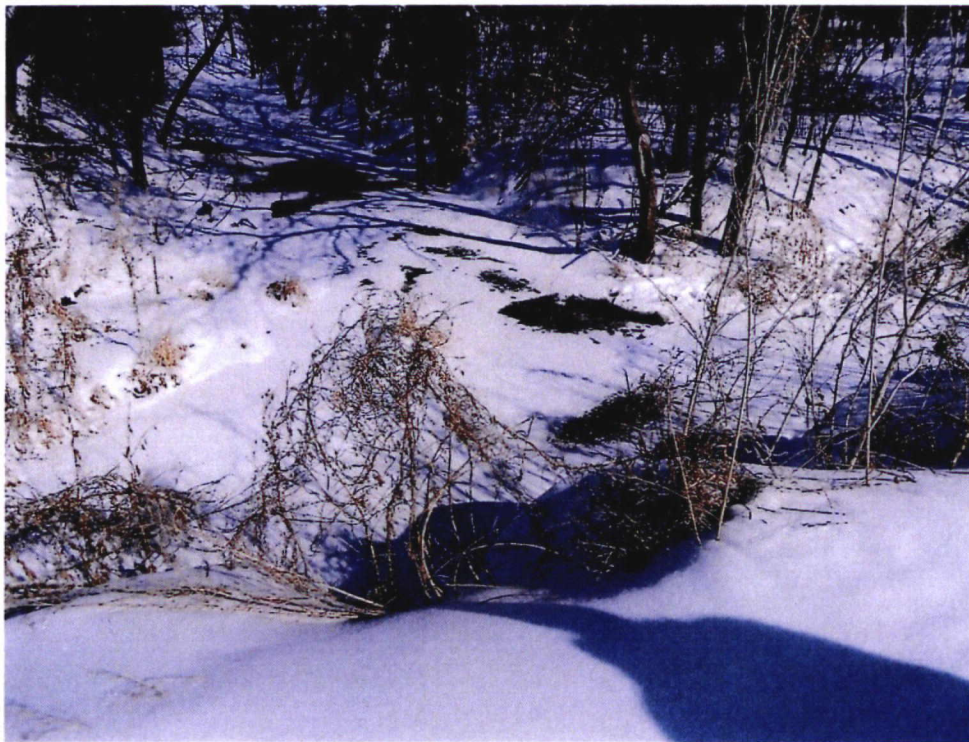
View north of ditch upstream from culvert D

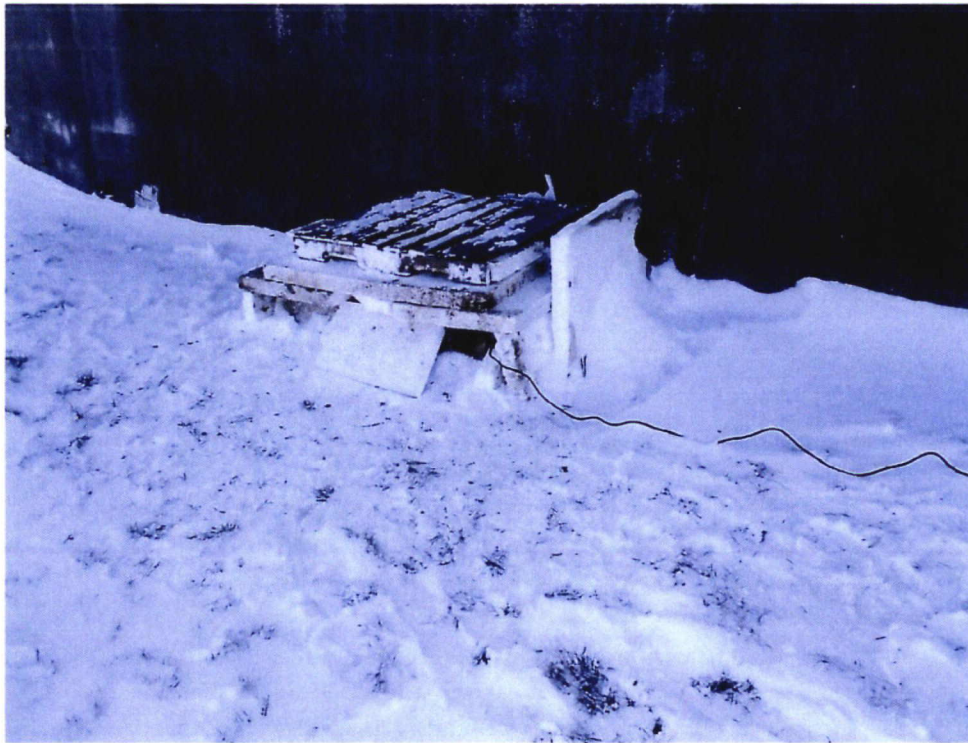
We returned to the AltEn facility to examine the digester that had not suffered a release. We observed a pile of Styrofoam insulation panels we presumed were covering the piping vault (see attached photo). We observed electrical wiring leading under the pile of insulation and presumed that to be for the heat lamp mentioned by Mr. Egr. We observed on the south side of the digester that had not suffered a leak a column of ice surrounded by caution tape (see attached photo). We could see a fitting above the column of ice actively releasing a liquid (which appeared to be freezing and creating the column of ice). We presumed this liquid was thin stillage and manure being released from the full or nearly full digester.

Insulation over piping vault on digester without leak

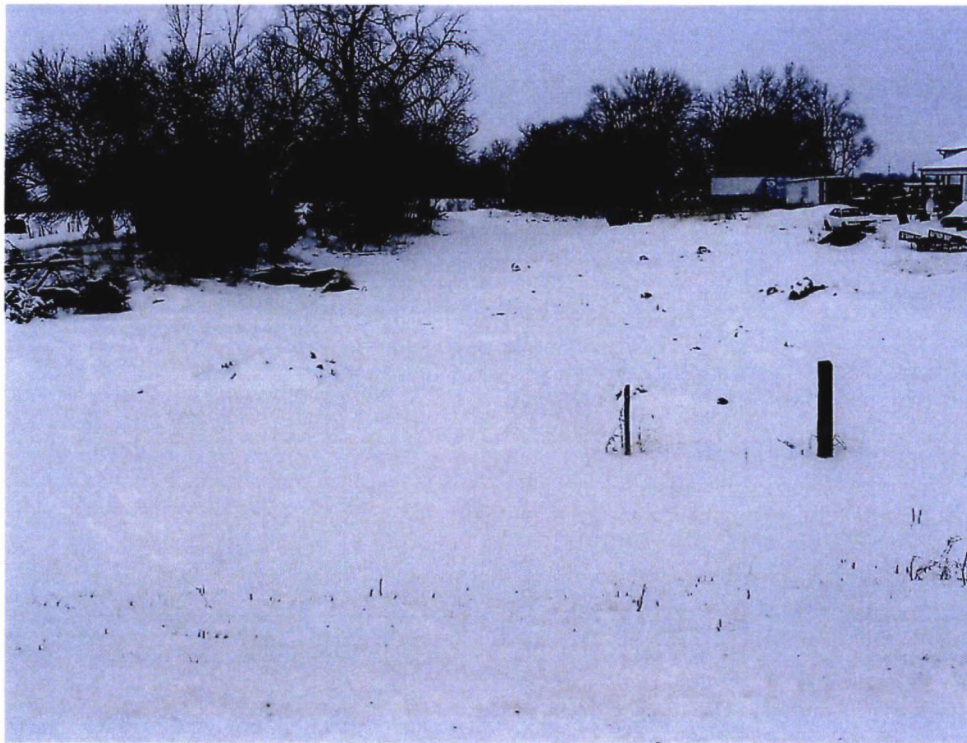
View north of ditch upstream from Stop #1

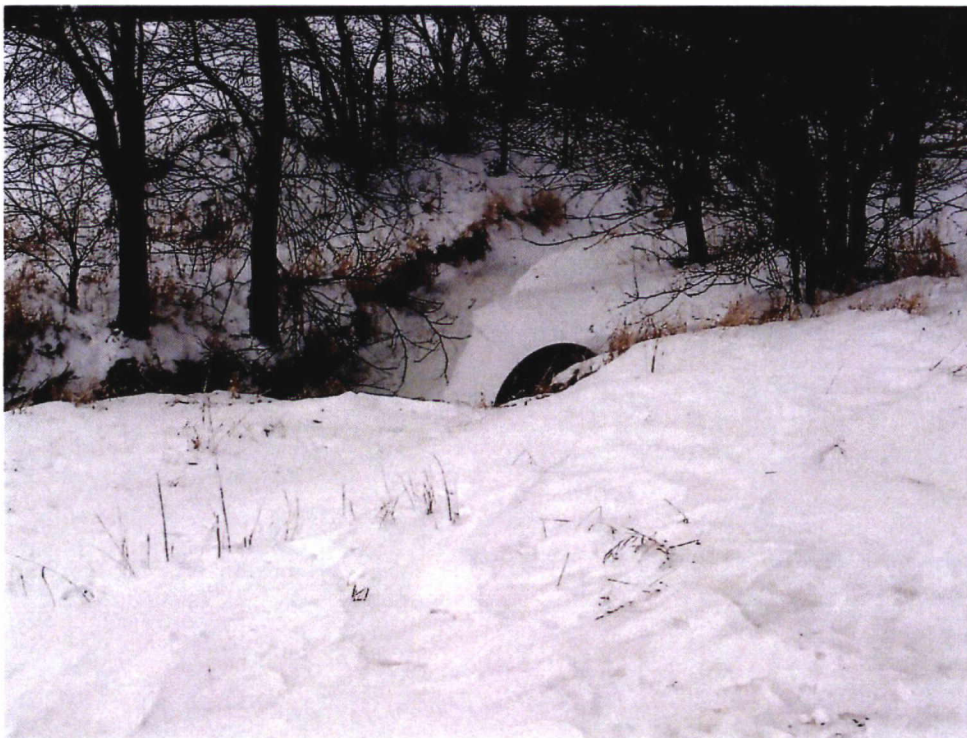
View west of ditch upstream from Stop #2

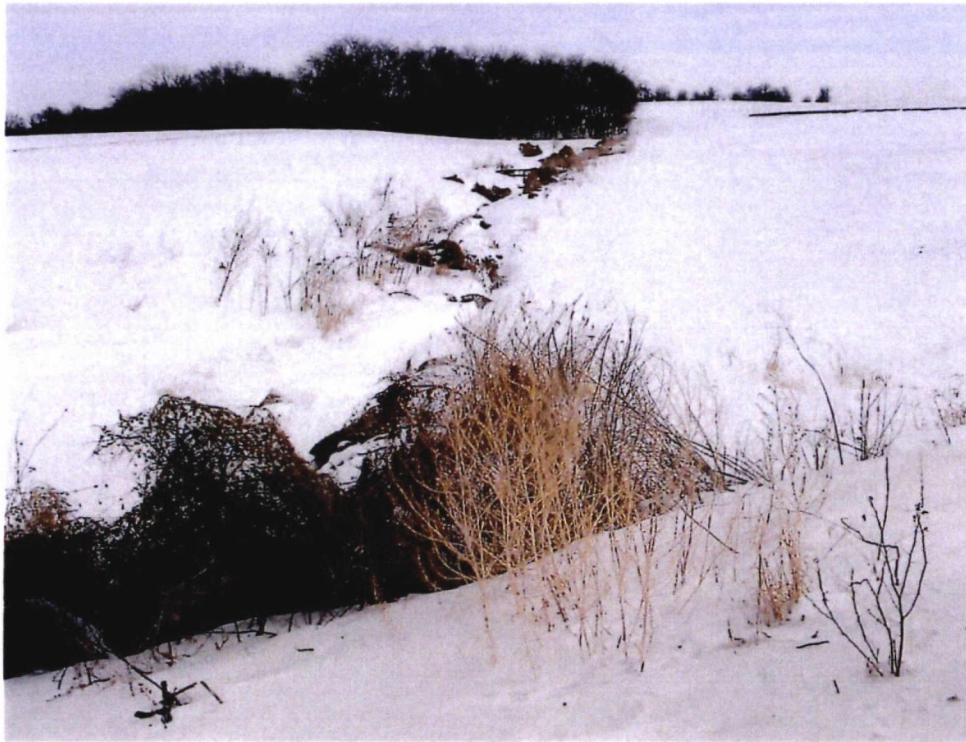
View east of ditch downstream from Stop #2

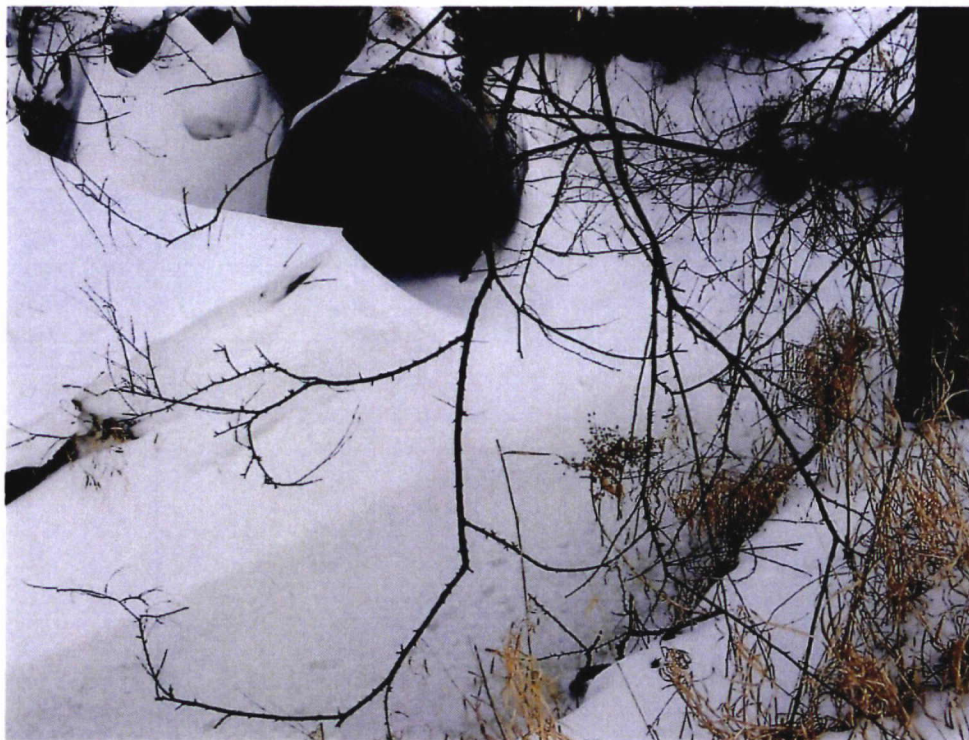
View east of upstream culvert inlet at Stop #2

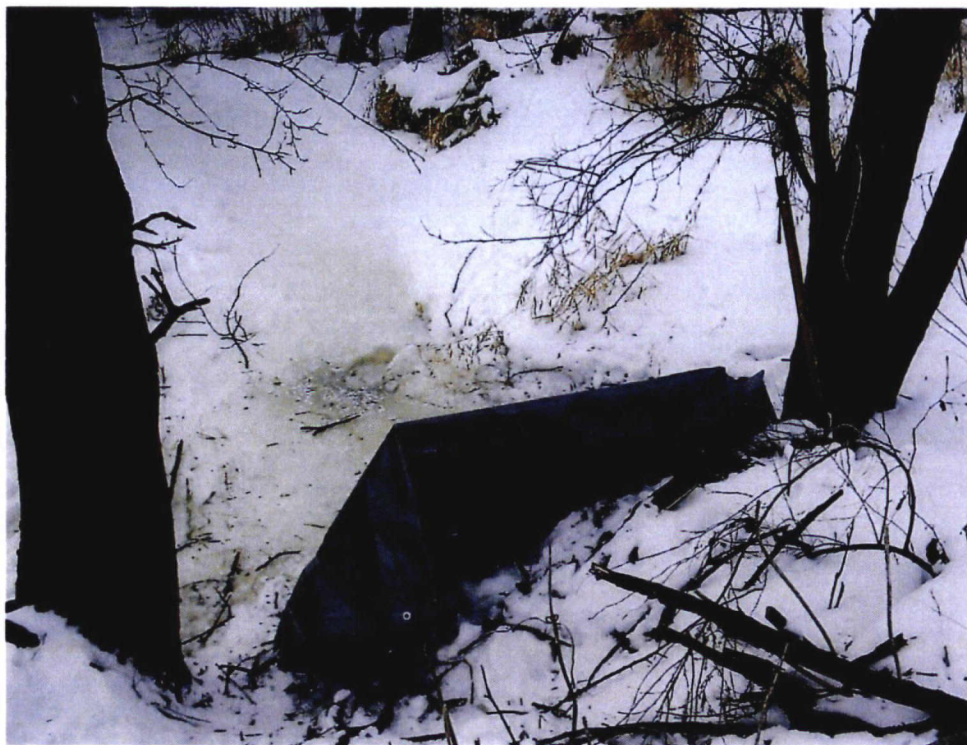
I proceeded to Stop #3. Stop #3 is located on road 7 about 1/2 mile north of road F. The surface of the liquid in the ditch at Stop #3 was frozen. I did not attempt to break through the ice to determine if there was unfrozen liquid below the ice. The ice had slight yellow/tan coloration. I observed plywood (or similar) wrapped with a tarp covering the inlet of the culvert. There were several sandbags placed at the base of the plywood/tarp to hold it in place (see attached photos). I dug through the snow at the downstream outlet of the culvert and found only ice. I did not attempt to break through the ice at the culvert outlet to look for unfrozen liquid.

View west of ditch upstream from Stop #3

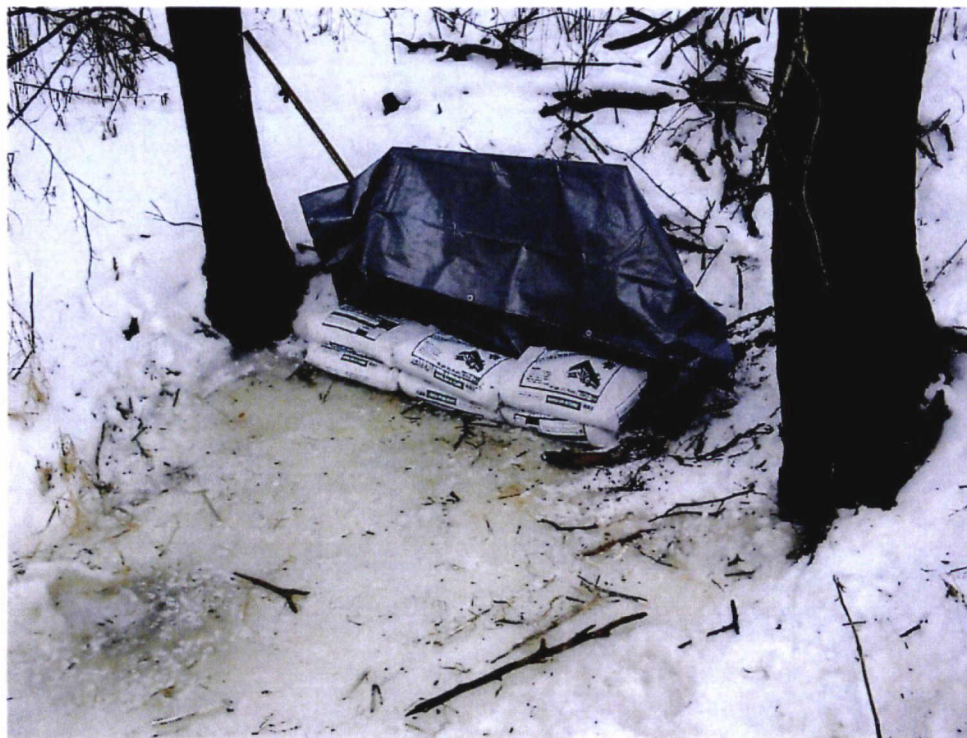
Containment structure in culvert inlet at Stop #3

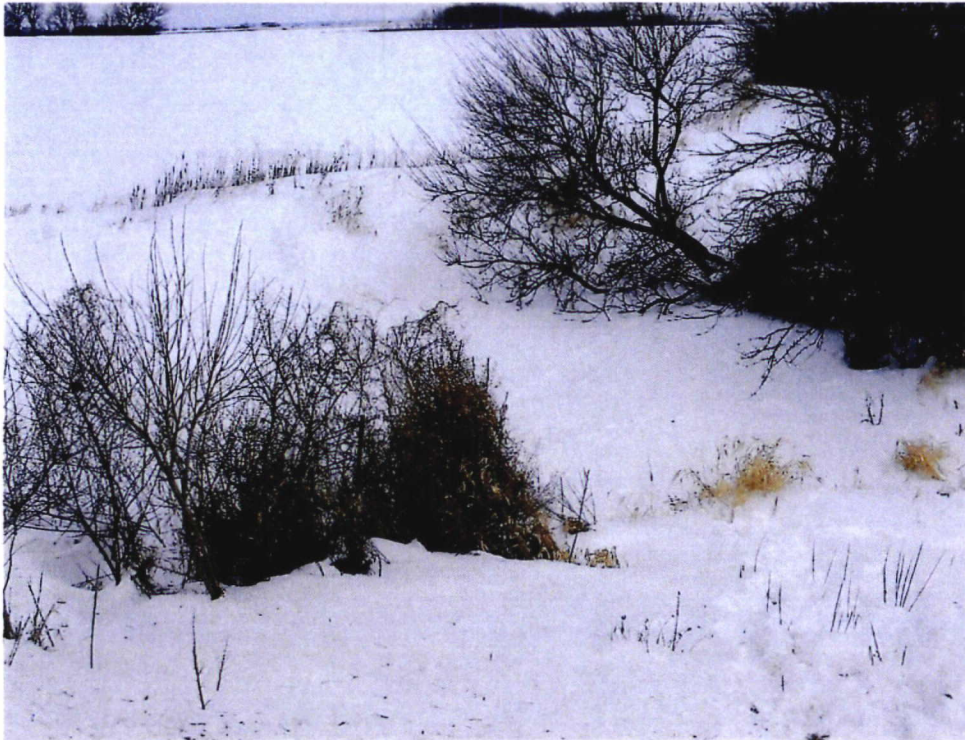
View east of ditch downstream from Stop #3

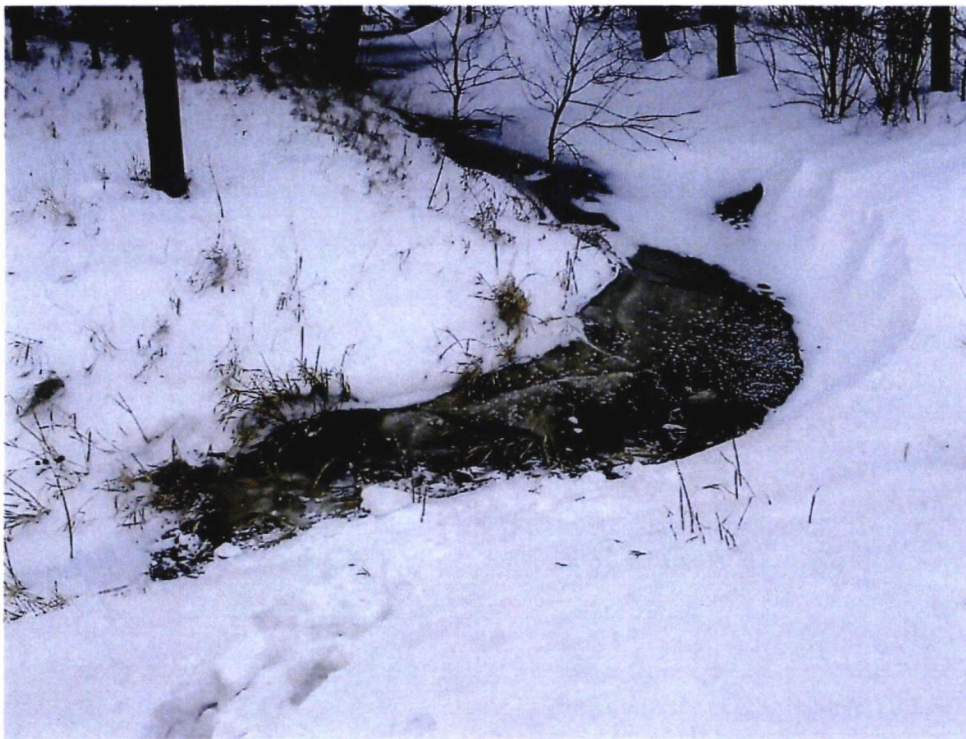
I proceeded to Stop #4. Stop #4 is located on road 8 about 1/2 mile north of road H. I observed brown-colored ice both upstream and downstream from Stop #4. Upstream from Stop #4, the ice was broken in many pieces as if it froze and the liquid below drained away (see attached photos).

View west of ditch upstream from Stop #4

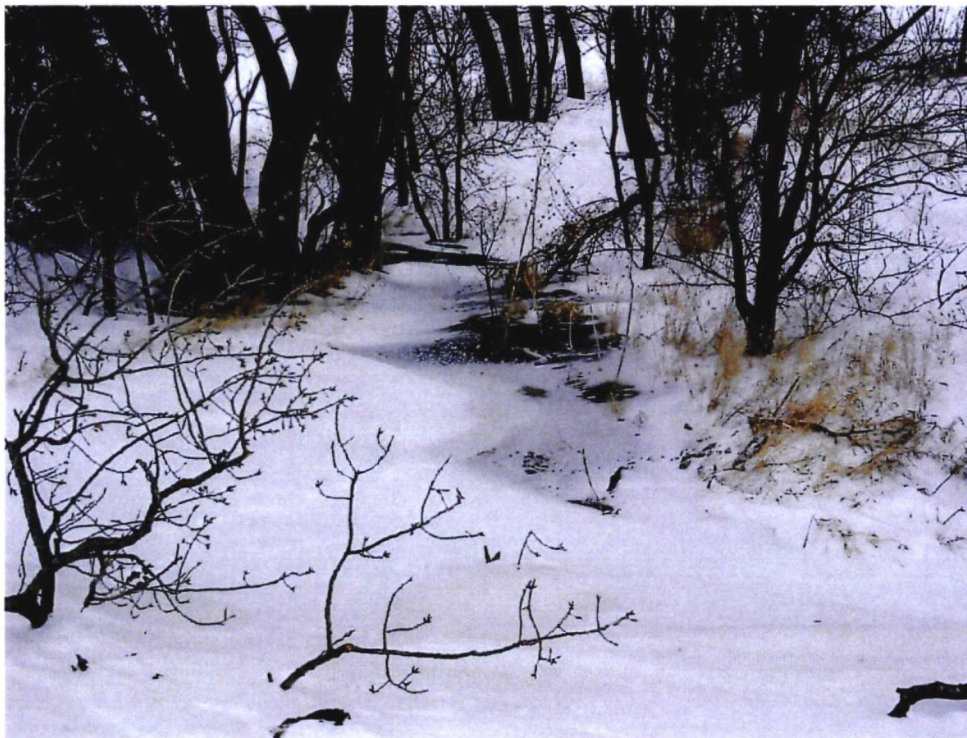
View east of ditch downstream from Stop #4

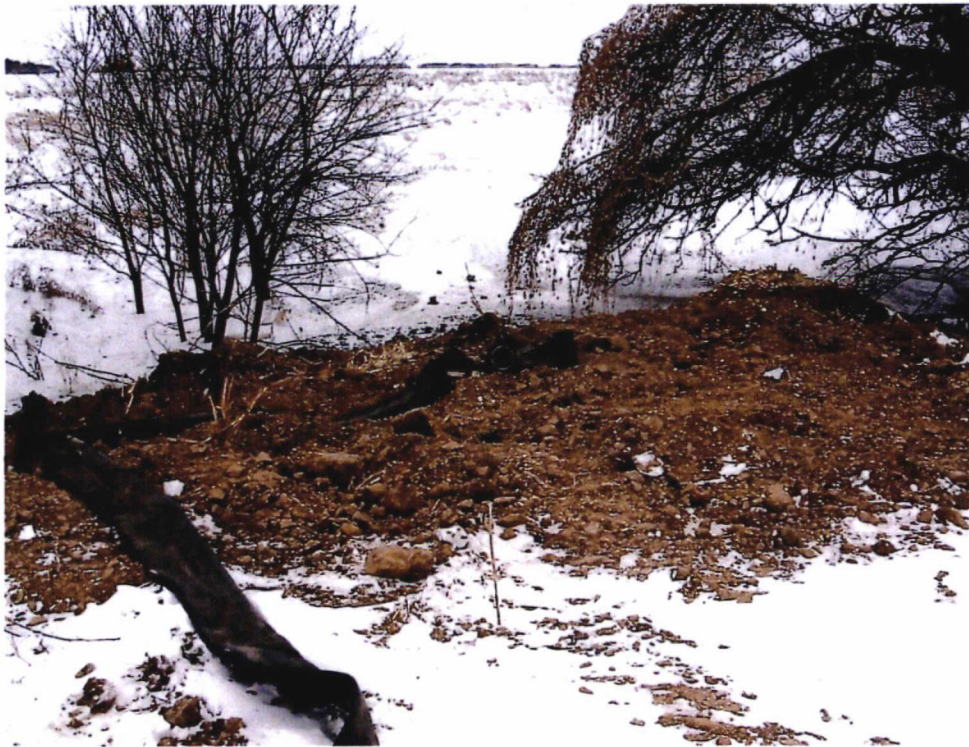
I proceeded to Stop #5. Stop #5 is located on a closed road (road 9) a short distance north of road J. I observed an earthen dam upstream from Stop #5. I did not see the hay bales or concrete rip-

rap I had observed at this location on February 13<sup>th</sup>. It is unknown if the bales and concrete were removed, or simply covered with earth. The volume of earth present was significantly greater than the volume of earth I had observed on the 13<sup>th</sup>. I observed brown ice both upstream and downstream of Stop #5. I made no attempt to break through the ice to determine if flowing liquid was present below the ice. I observed flexible piping laid out near Stop #5 and extending some distance to the north (see attached photos).

View west of dam upstream of Stop #5

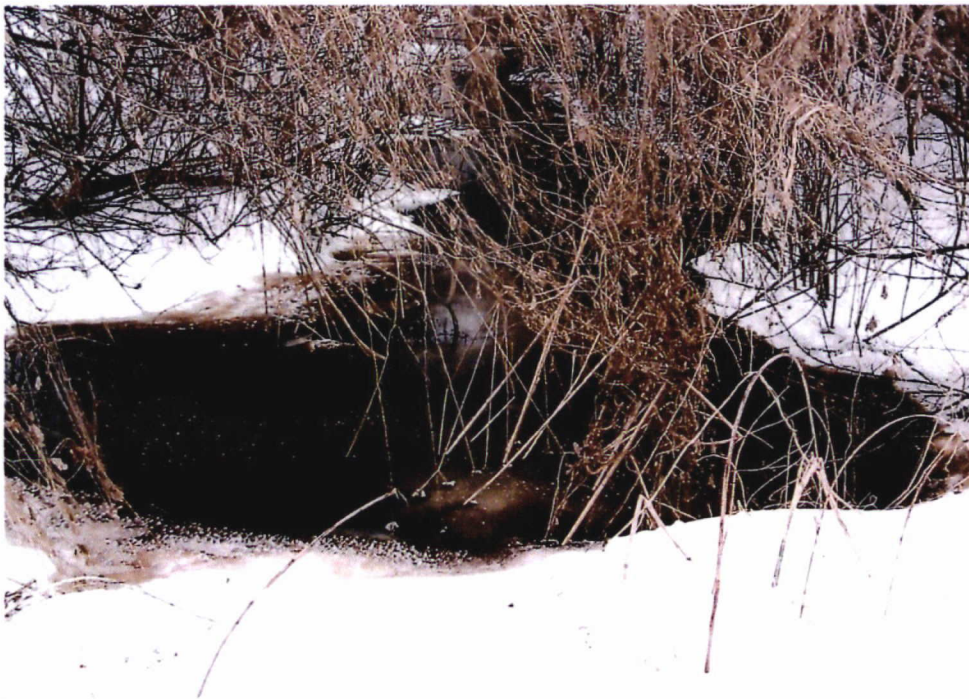
View east of ditch downstream from Stop #5

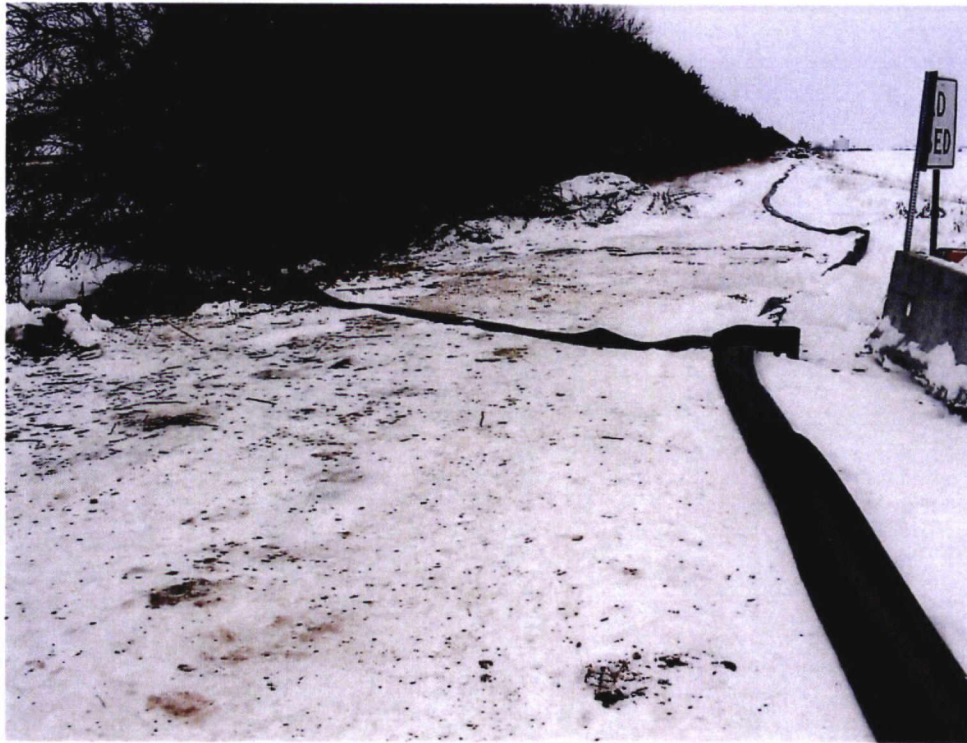
View north of piping laid out at Stop #5

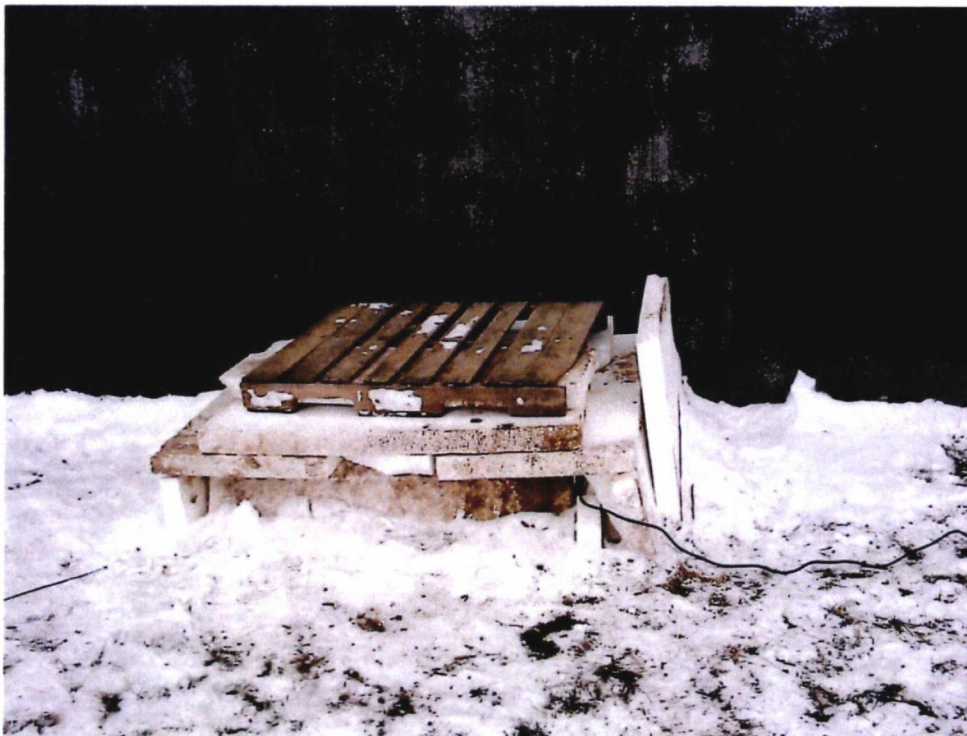
Insulation over piping well on digester w/out leak

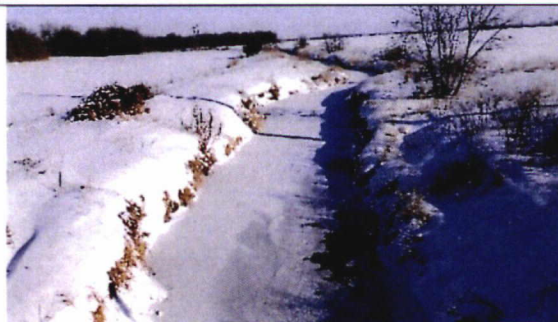
Clear Creek at this location was 99% ice/snow covered. There was a couple of open water areas, but site is currently not impacted from the AltEn LLC thin stillage discharge. Photo is looking north (upstream).

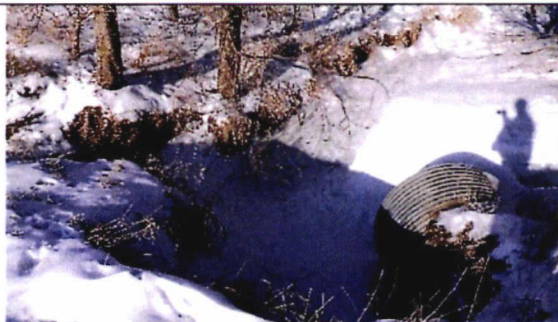
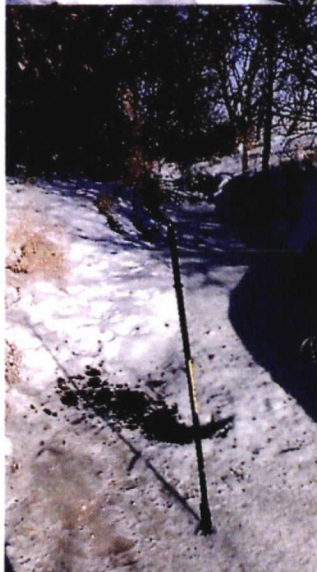
**STOP 2 – North of the Intersection of  
COUNTY ROADS 6 & F**

I found no evidence of the AltEn LLC thin stillage discharge reaching this location. I chopped a hole in the ice (~10 inches thick) to the channel's substrate. It was completely frozen, with no water below the ice. Photos were taken looking west/northwest (upstream).

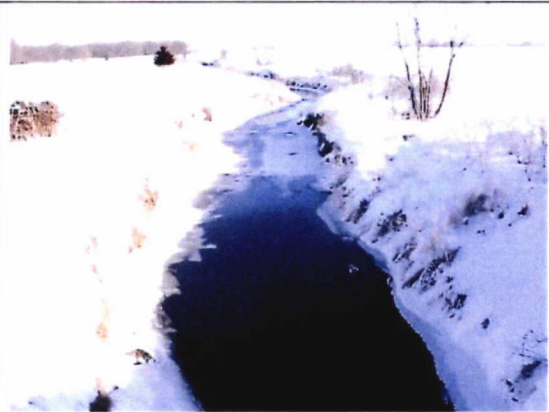
Nothing to see here other than water and ice;  
no apparent impacts.

Photo looking north from Highway 66 bridge.

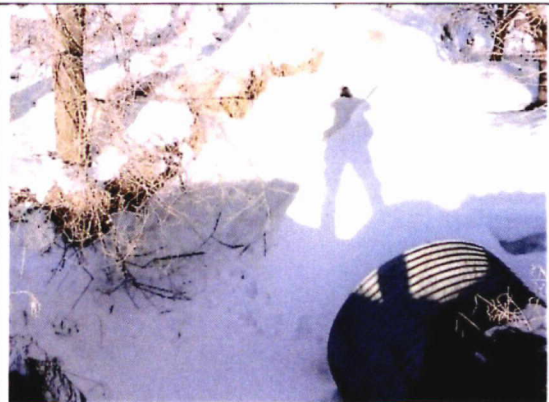
**STOP 2 – North of the Intersection of  
COUNTY ROADS 6 & F – 0845 hrs.**

No apparent contamination; same as  
described by Greg Michl 2-18-21.

Photo looking west.

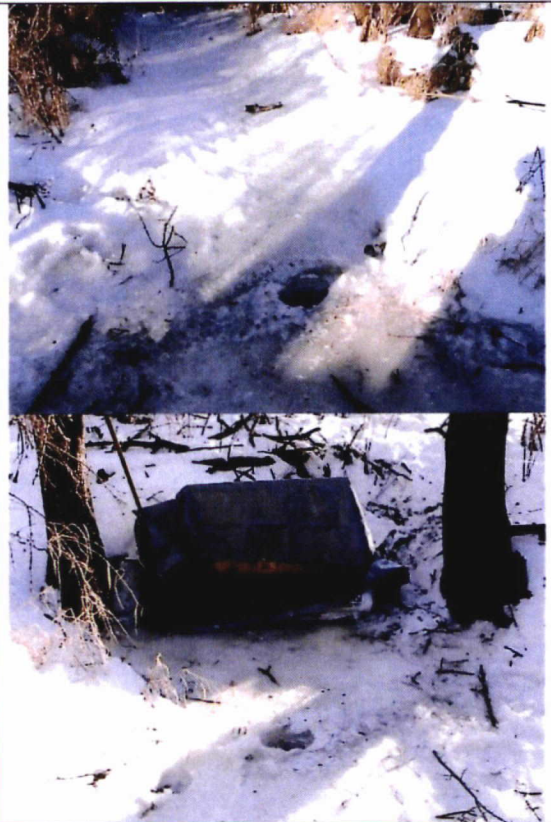
Top photo looking west.

Bottom photo looking east at containment structure.

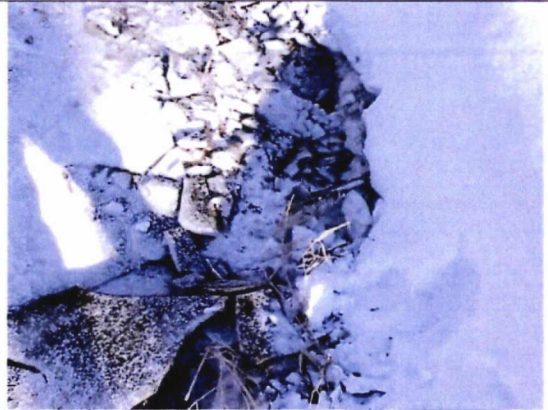
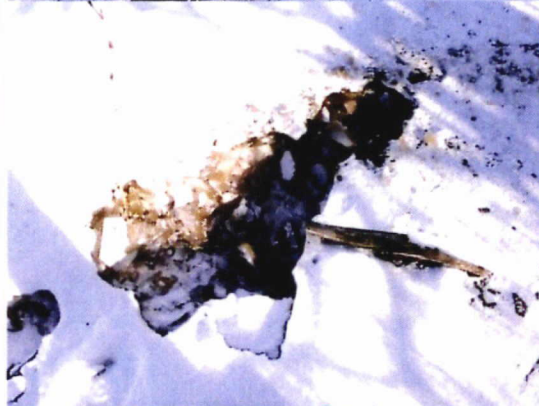
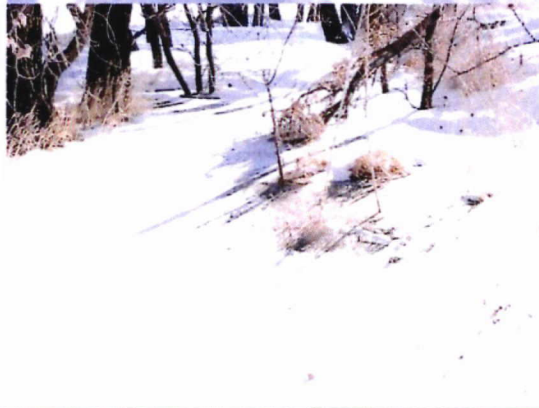
**STOP 4 – County Road 8, North of Road H  
– 0905 hrs.**

Appears to be as described by Greg Michl on 2-18-21. Contamination evident.

Top two photos looking down at frozen contamination on west side of county road.

Bottom photo looking east from east side of county road.

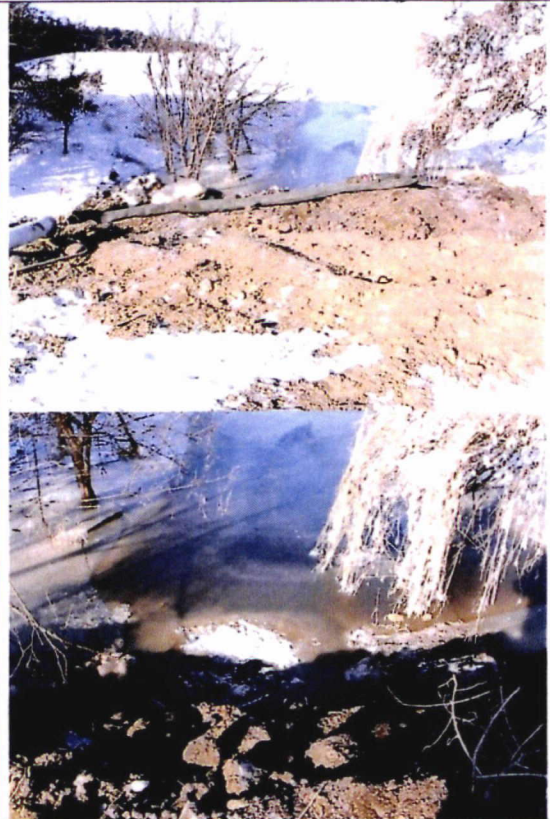
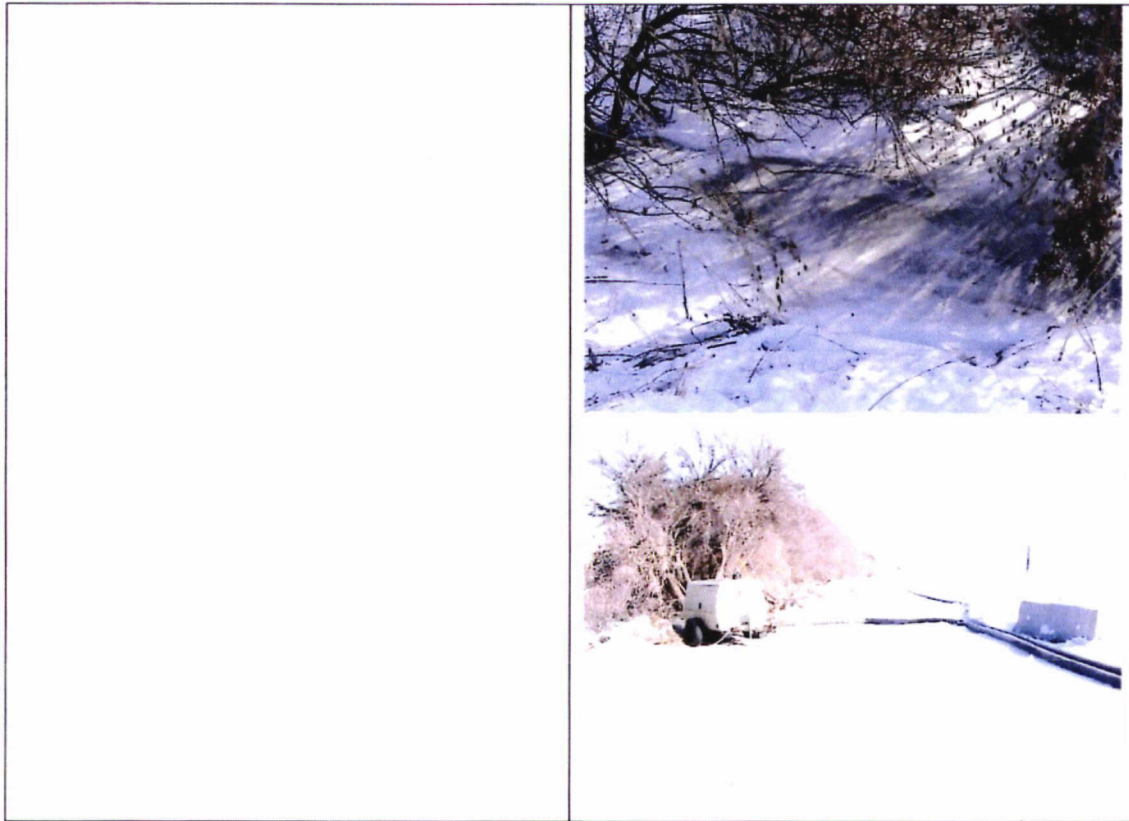
**STOP 5 – UN-L Eastern Extension – North  
of County Roads 9 & J – 0915 hrs.**

Generator and piping present, but no pumping going on.

Top photo (page 5). Looking east at frozen contamination.

Bottom photo (page 5). Looking north at overview of generator (not operating) and piping.

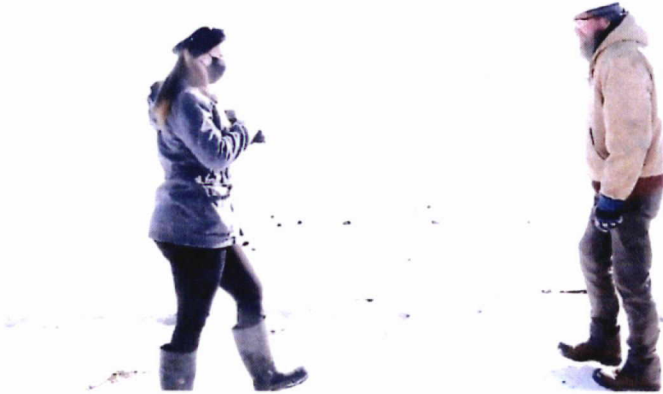
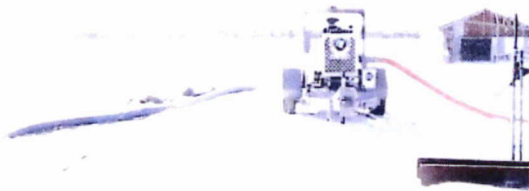
Facility pumping water from emergency lagoon to active wastewater lagoons in preparation for pumping material from north digester. NDEE Inspector Hillary Stoll on-site for inspection of emergency lagoon (see Photos below). Top photo looking east across "emergency lagoon." Bottom photo (looking south) shows water from "emergency lagoon" being pumped north to site wastewater lagoons.
