BEFORE THE NEBRASKA DEPARTMENT OF ENVIRONMENT AND ENERGY

IN THE MATTER OF	)	
AltEn, LLC,	)	CASE NO. 3546
	)	
FID # 84069	)	EMERGENCY COMPLAINT
	)	AND ORDER
Respondent.	)

Release of Thin Stillage and Cattle Manure from Digester at AltEn LLC, IIS #84069, RA  
#021221-NH-0845

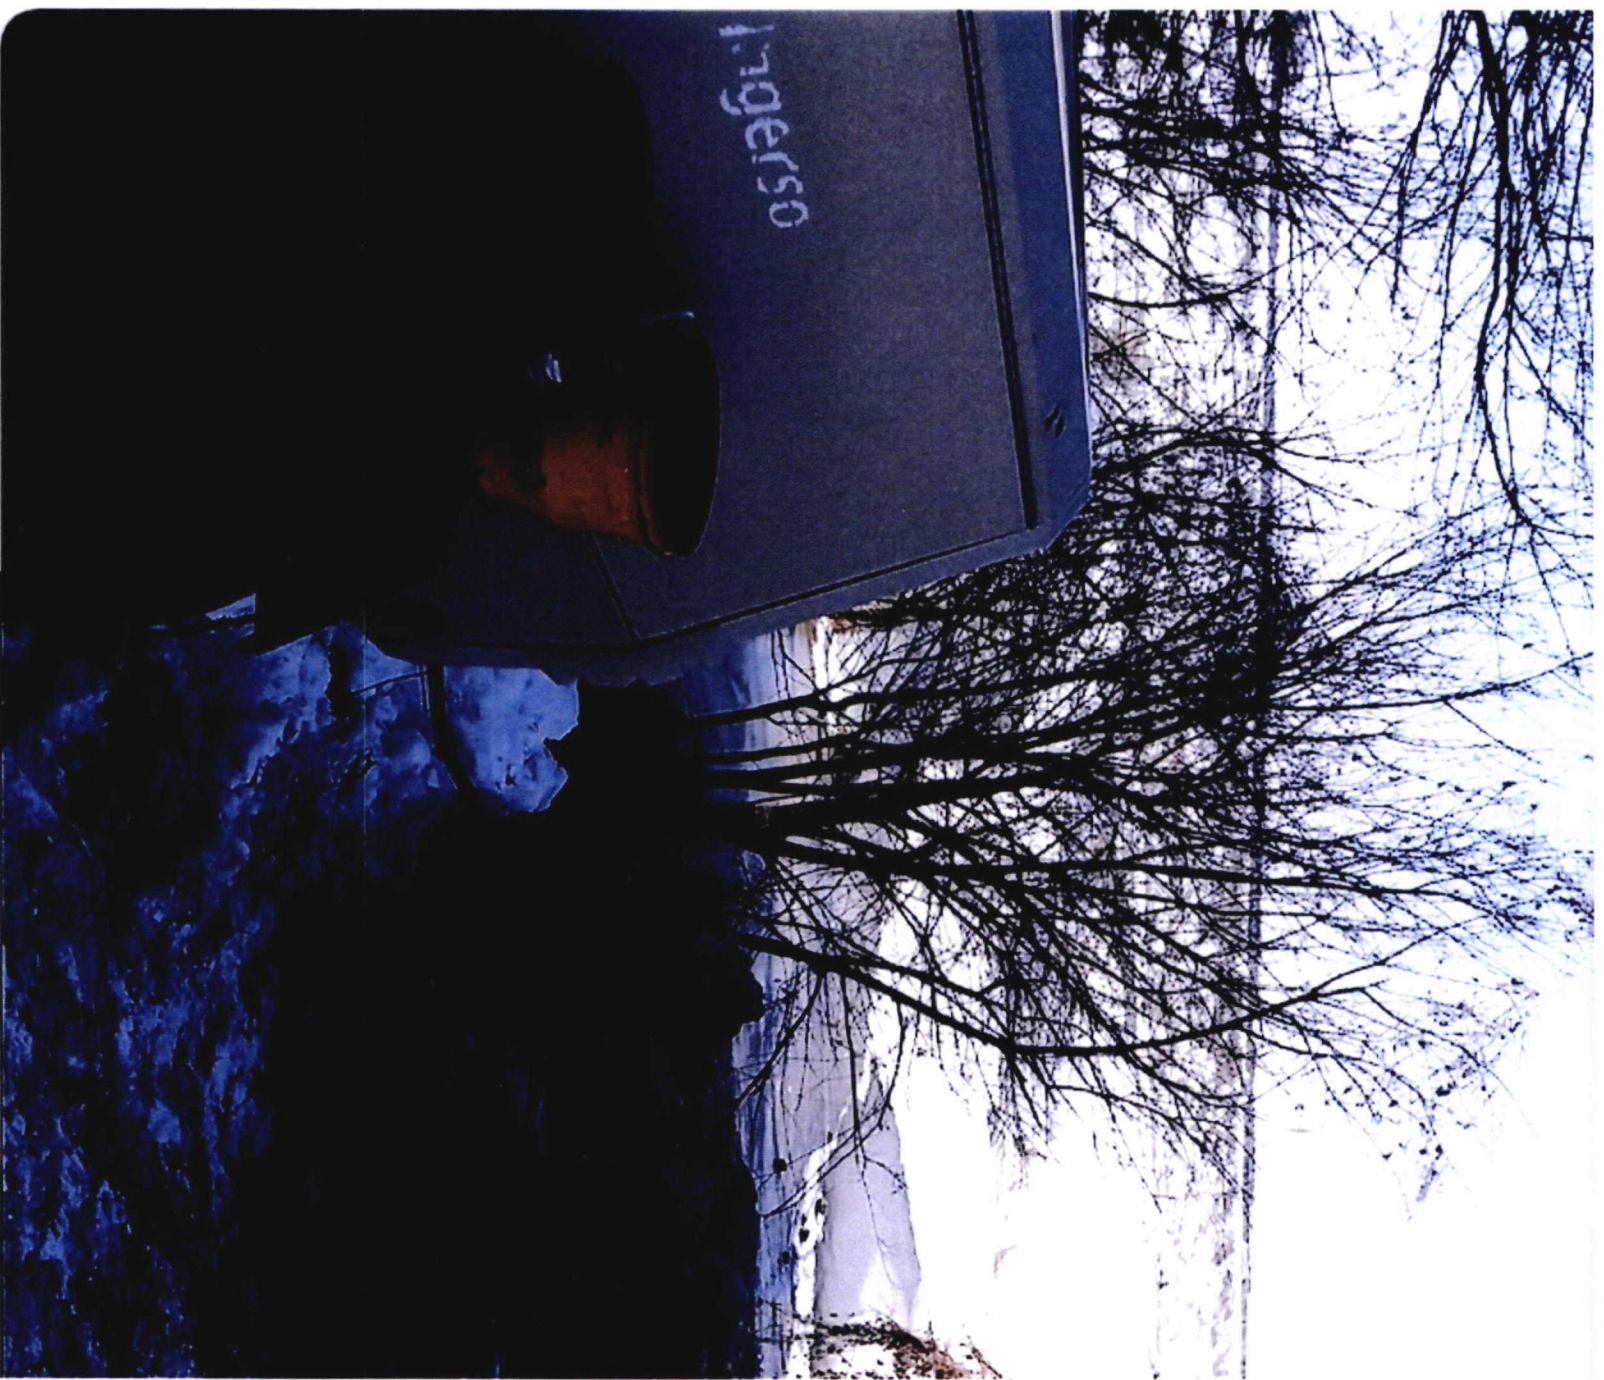
20210025469

I was also examining the spill yesterday and took the photograph below where AltEn's contractor was pumping the spillage from Johnson Creek back to the lagoon from the intersection of county roads 9 and J.
